TECHNICAL REPORT

Community Civil Protection Mechanism Assessment Mission

Italy Earthquake 2009

April 2009

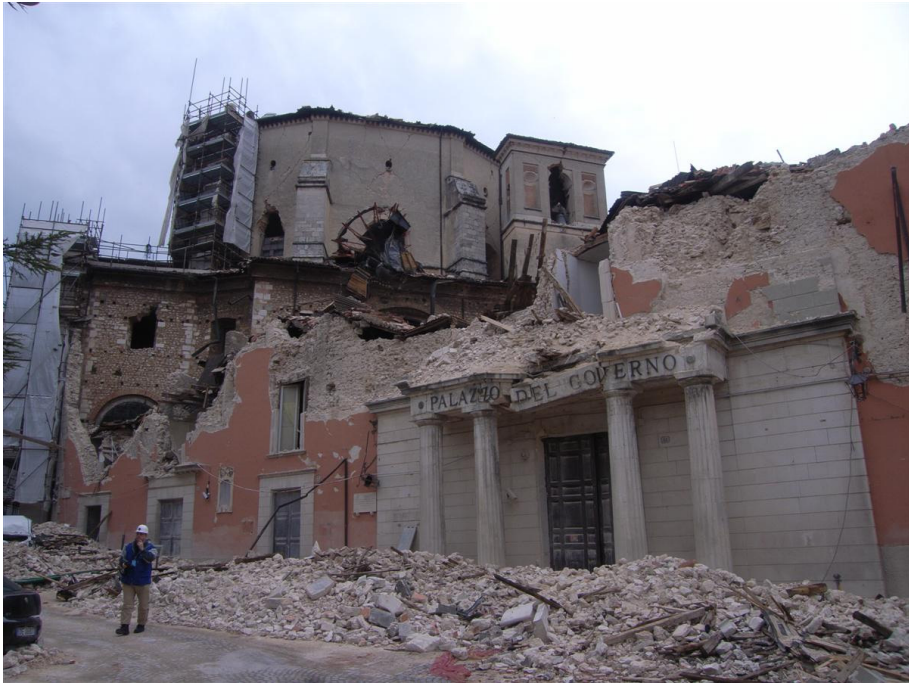
Figure 1: Damage to the Prefecture building.

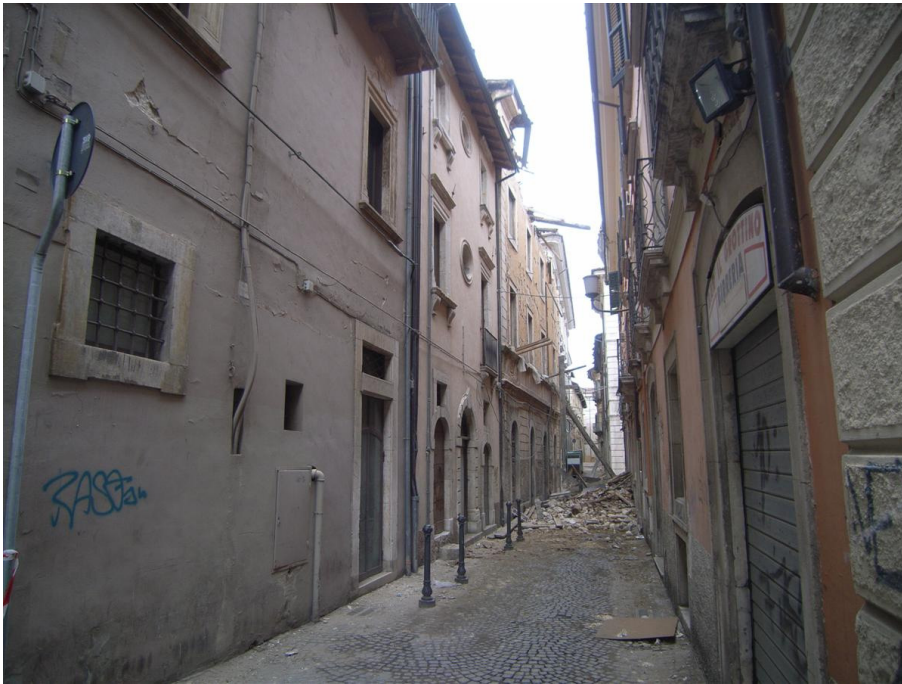
The situation is made worse by the facts that the whole centre of L'Aquila has been evacuated, most of the buildings are likely to collapse even after small aftershocks, and the narrow roads are full of debris, Figure 3. Accessing the individual buildings is per se a major problem. Removal of the debris from the roads might make the access easier; however, this is not possible in most cases, due to the need to identify and collect the stone blocks which fell from monuments and palaces in view of their possible reconstruction, Figure 4. Fire-fighters have so far been active in measures having high impact for preserving the identity of the places and of the communities, such as retrieving from debris the relics of saints, removing bells from leaning campaniles, Figure 5, removing paintings and art crafts. An intervention which might work as an example is the sheltering of the cathedral of Onna, Figure 6, a village of which very little else remains.

Figure 3: Street in the historical centre of L'Aquila

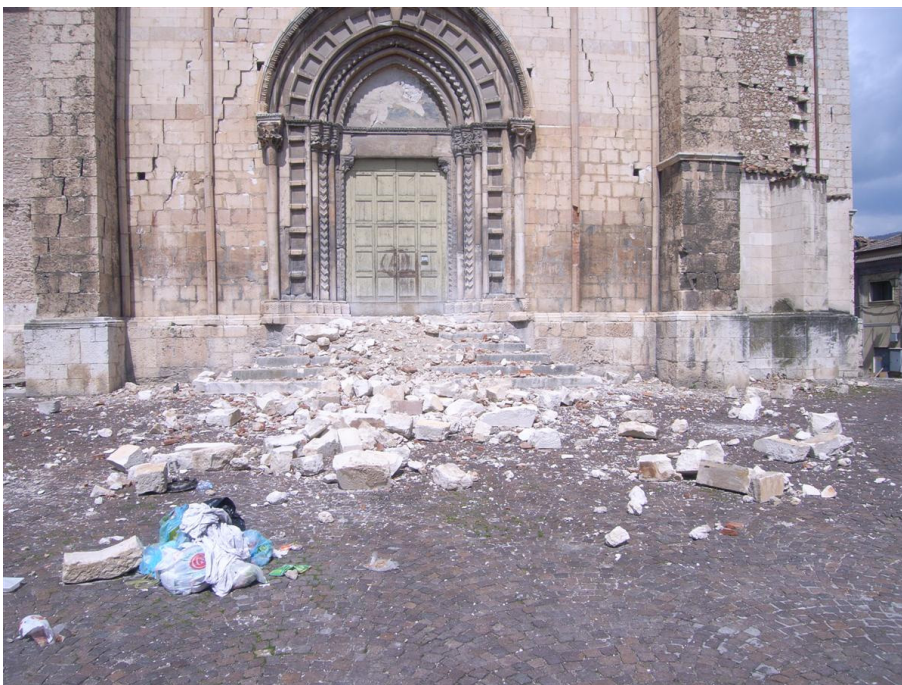
Figure 4: Stone pieces falling from monuments and needing collection

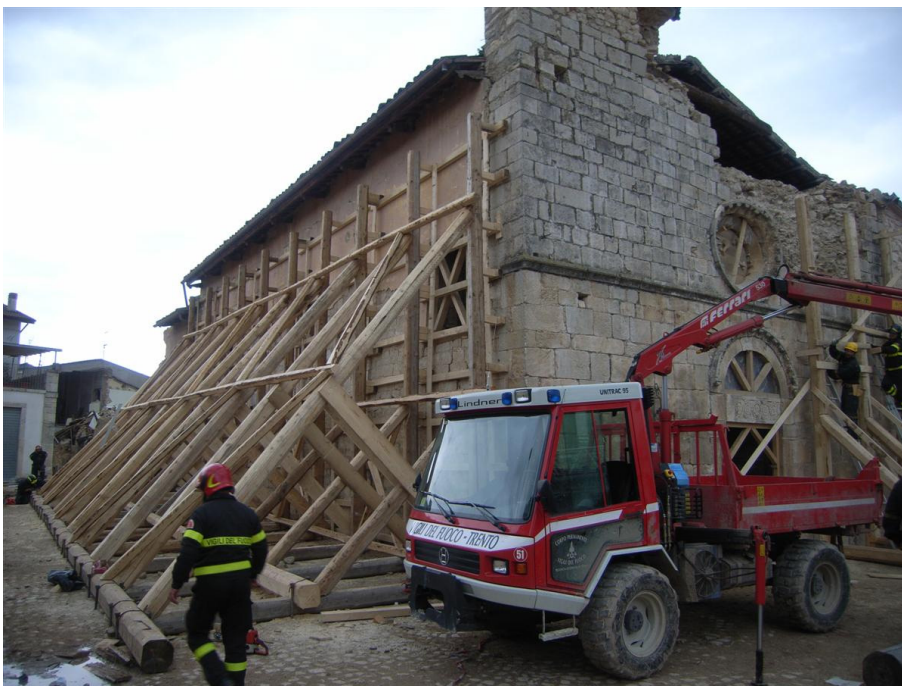
Figure 6: Sheltering of the Cathedral of Onna

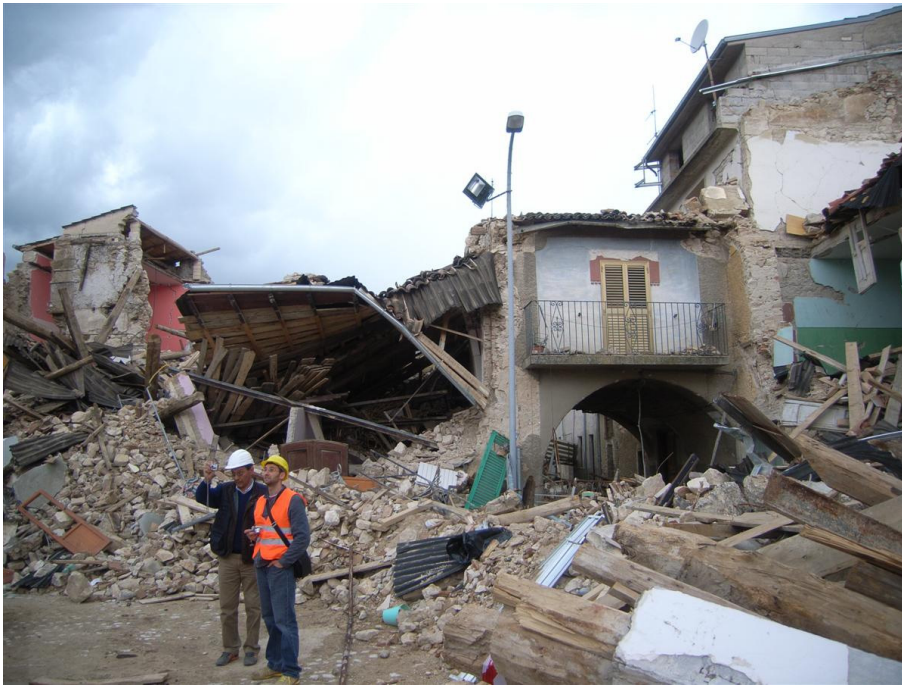
Technical elements such as quality of construction, lack of maintenance and absence of steel ties have contributed to the failure or poor behaviour of old masonry buildings, Figure 7, and this does not come as a surprise. On the other hand, in many cases, old masonry buildings in which steel ties had been placed apparently did not suffer any damage, Figure 8.

Figure 7: Collapse of old masonry buildings in Onna

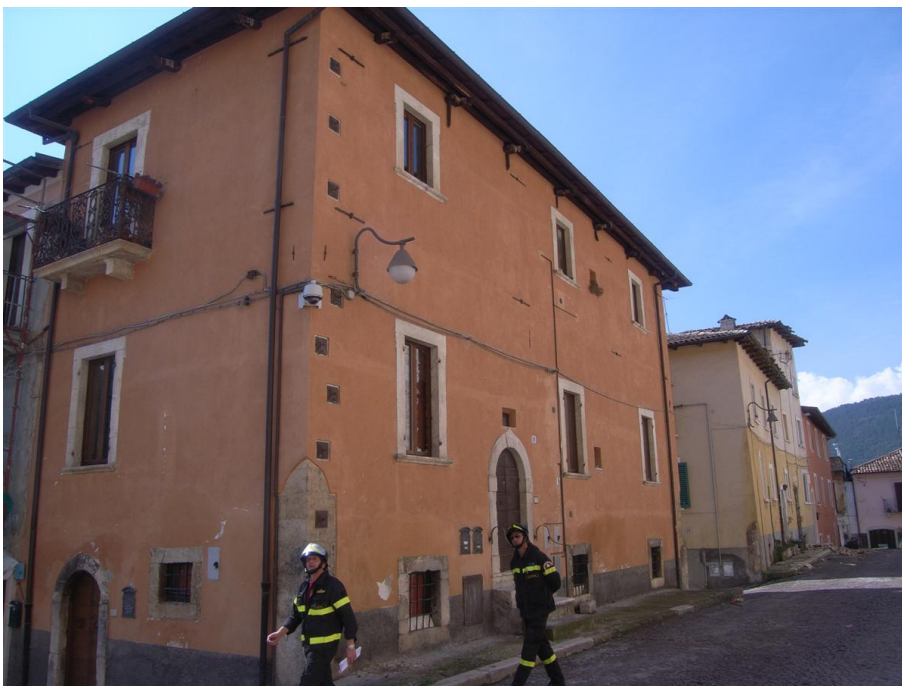
Figure 8: Historical centre of L'Aquila: apparent good performance of old masonry building strengthened with ties

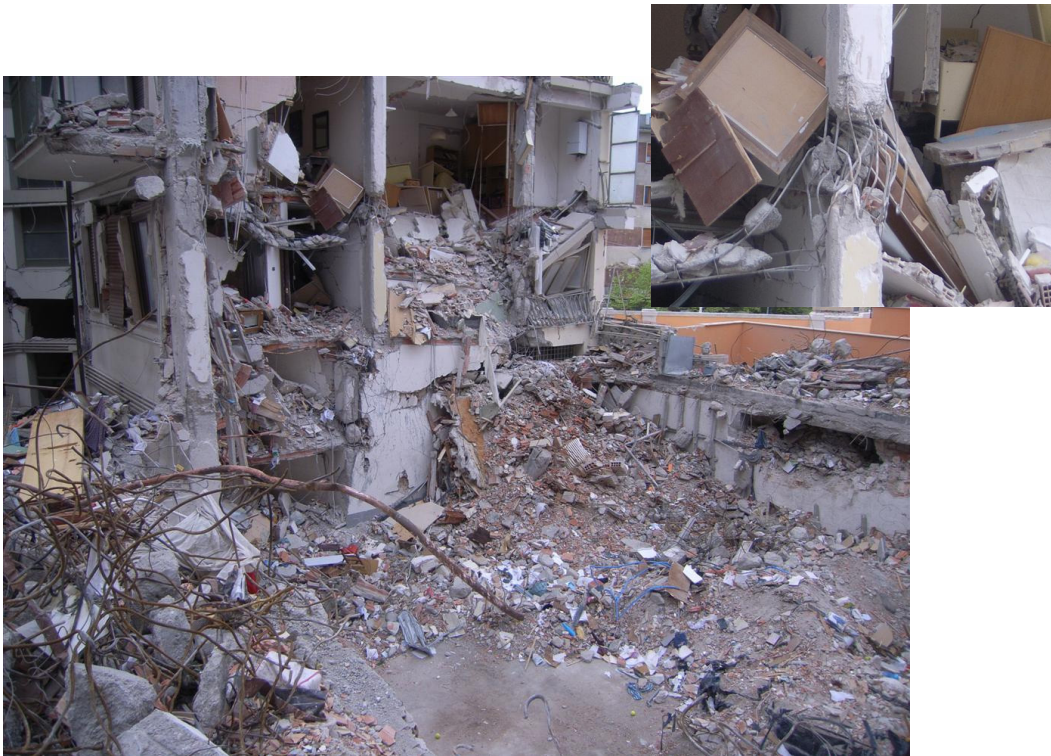
A large number of old reinforced concrete buildings, possibly built before seismic provision were enforced, suffered extensive damage and some of them collapsed. Old construction practice and materials (smooth steel rebars, possibly low quality concrete, insufficient confinement) contributed to the poor seismic performance, Figure 9.

Figure 9: Collapse of old reinforced concrete building

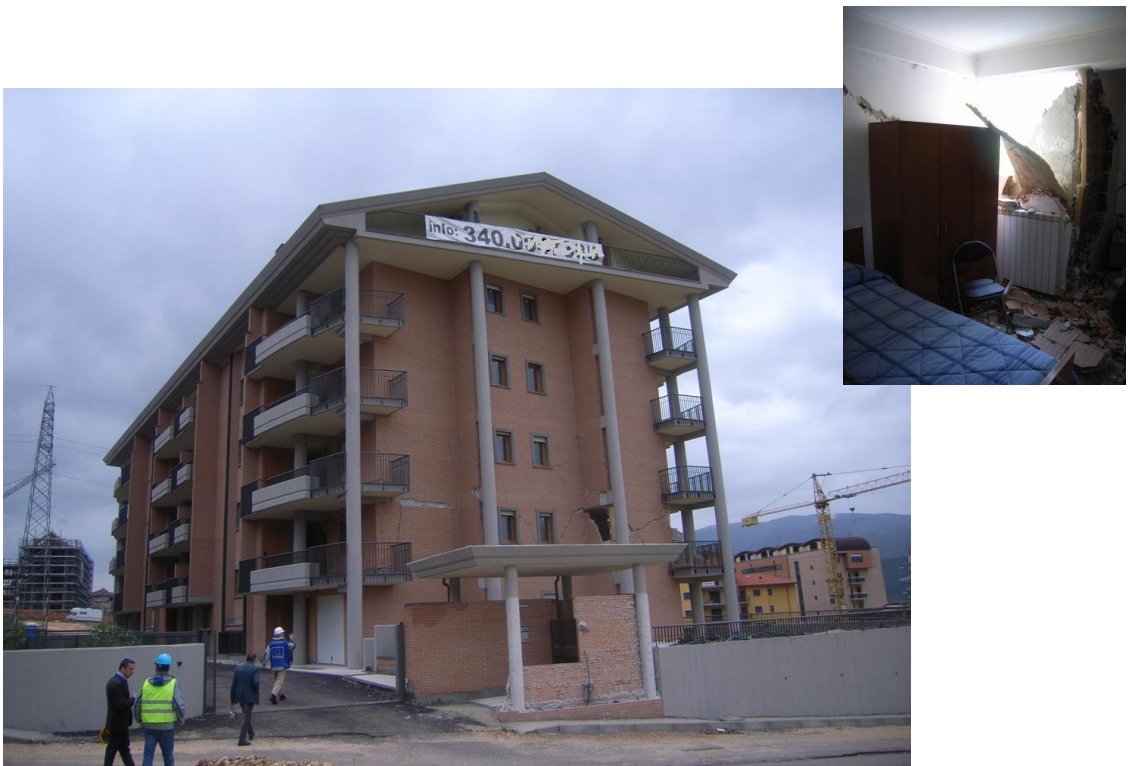
What was found to be particularly surprising was the extent of damage in recent, or even new, buildings. As a rule, the reinforced concrete frames did not suffer much damage, in most cases with a width of cracks compatible with minor or no yielding of rebars, whereas the damage to infill walls and partitions was almost total. Apparently, this is due to the fact that limits in deformations were enforced by the Italian regulations only after 1996; however, the same kind of damage was found in buildings which had been just completed, Figure 10 therefore there are possibly lessons to be learnt about the importance of stiffness in the design of ductile structures.

Figure 10: Very recent building which suffered extensive nonstructural damage

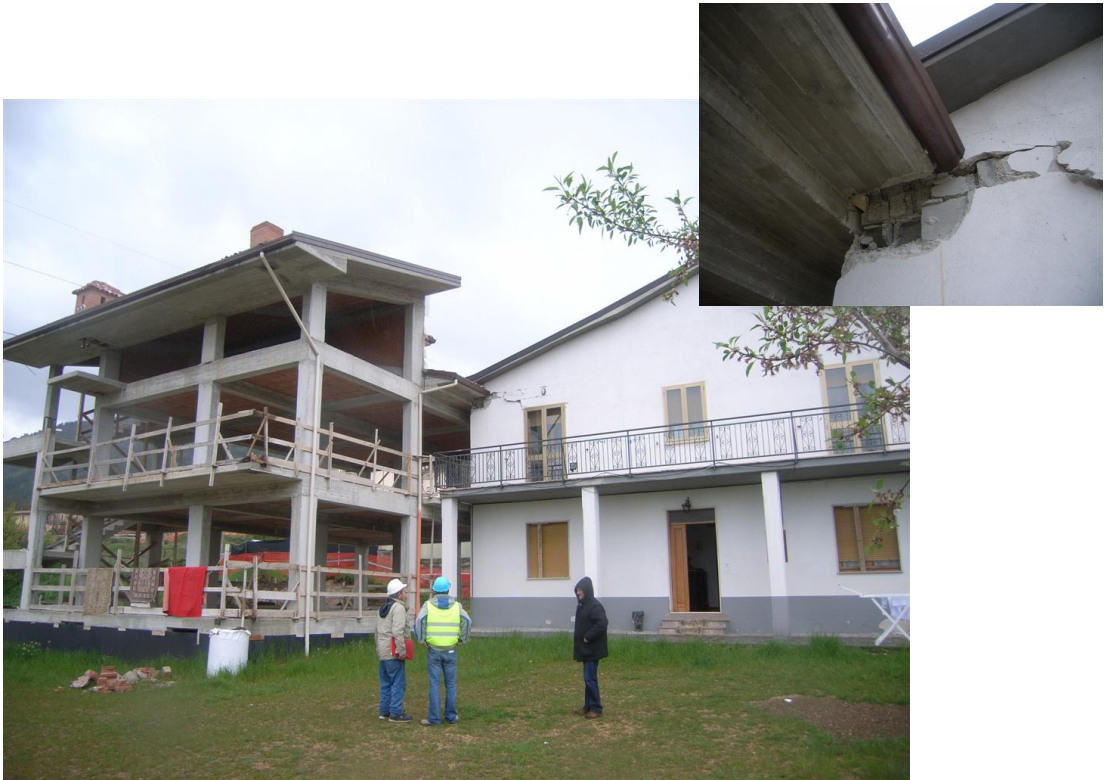
Insufficient seismic separation joints, or even the absence of them, were found to be the reason for the failure of many otherwise well conceived buildings, Figure 11.

Figure 11: Consequences of the lack of seismic separation joint

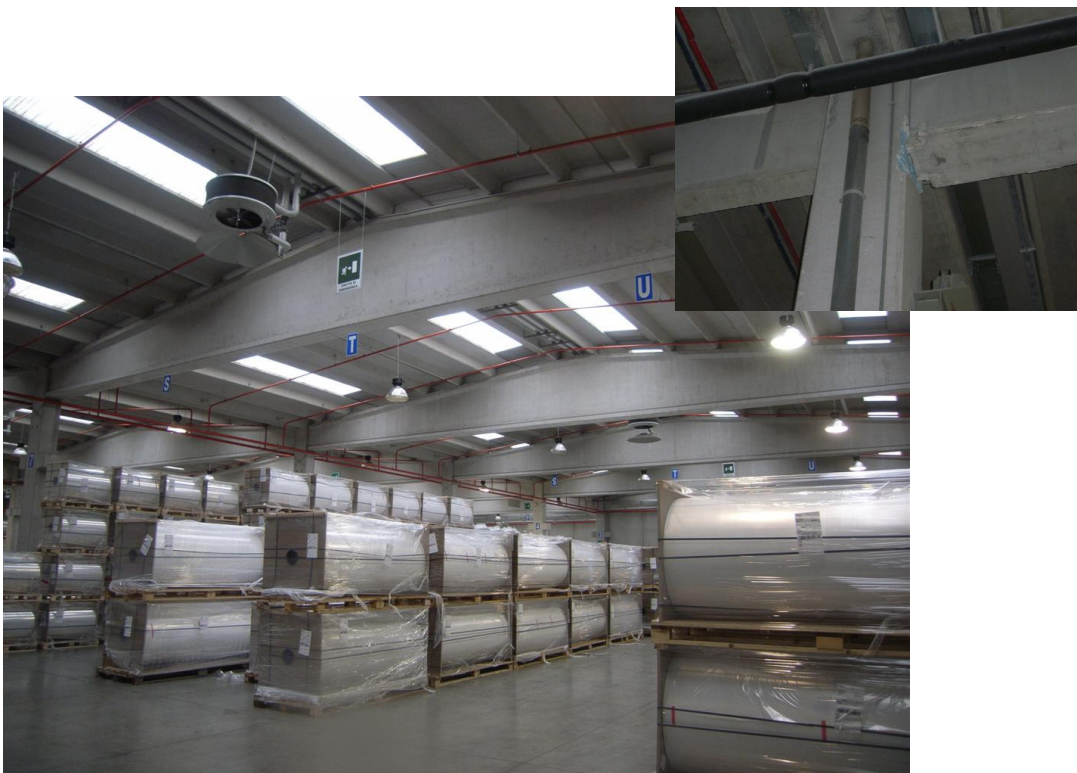
The few observed industrial buildings, mainly precast reinforced concrete structures, Figure 12, behaved very well. In the few cases in which damage was reported, it related to excessive displacements in the joints, and was already being repaired.

Figure 12: Industrial building
