A SHIP RECYCLING FACILITY IN TURKEY

Site inspection report application 34

European Commission DG Environment

Report No.: 2020-1261, Rev. 0 Document No.: 11HSGMMR-2

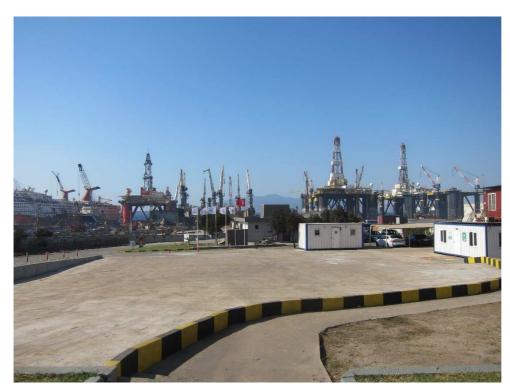
Clear access routes for firefighting and ambulances were observed on-site

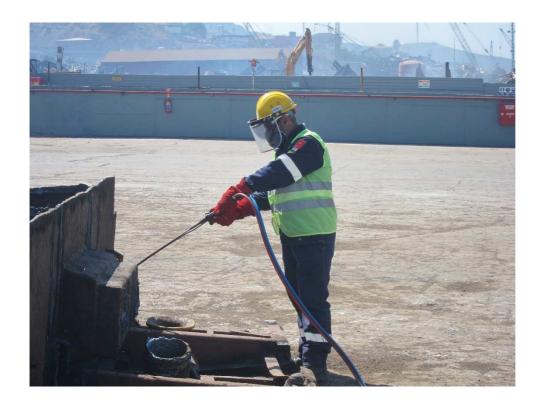
Helmets, shoes, eye protection, gloves and respiratory masks were worn throughout the operation.

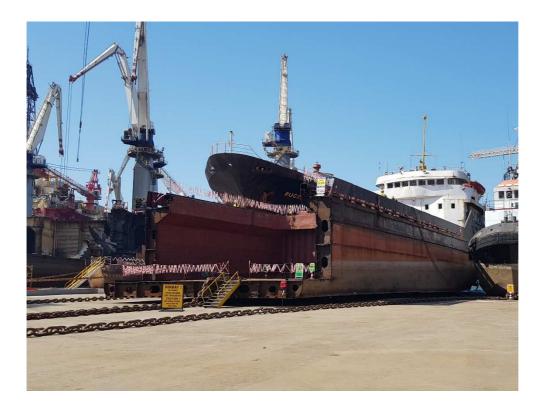
The evaluators could observe access to the vessel under dismantling is by ladder.
Secondary access is by basket lifted by crane.

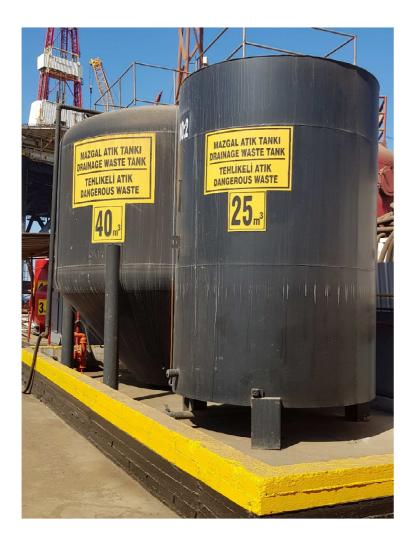
Drainage system runs across the plot (two main drainage lines in total, and one on the righthand side).

The drainage system is connected to two storage tanks on the right-hand side of the plot (looking towards the sea).

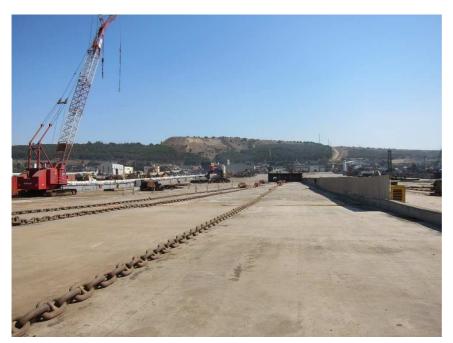
It could be established that the impermeable flooring was continuous during the site inspection.

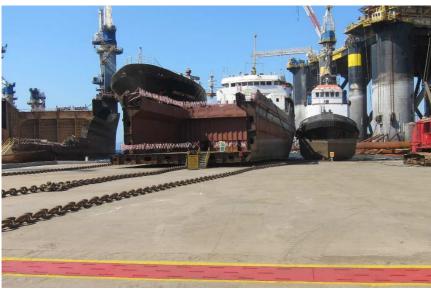
The vessel being dismantled during the site inspection was landed in June 2020.

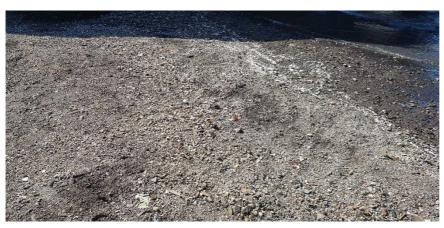
The permeable area between the sea line and the drainage line seemed to be newly cleaned, and little debris was seen during the site inspection.

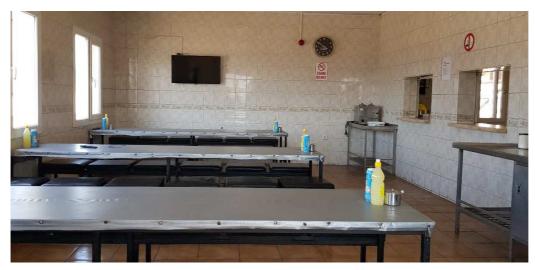
The workers had a canteen, sanitary and washing facilities and cloakrooms
