A SHIP RECYCLING FACILITY IN TURKEY

# Site inspection report application 36

European Commission DG Environment

**Report No.:** 2021-0063, Rev. 0

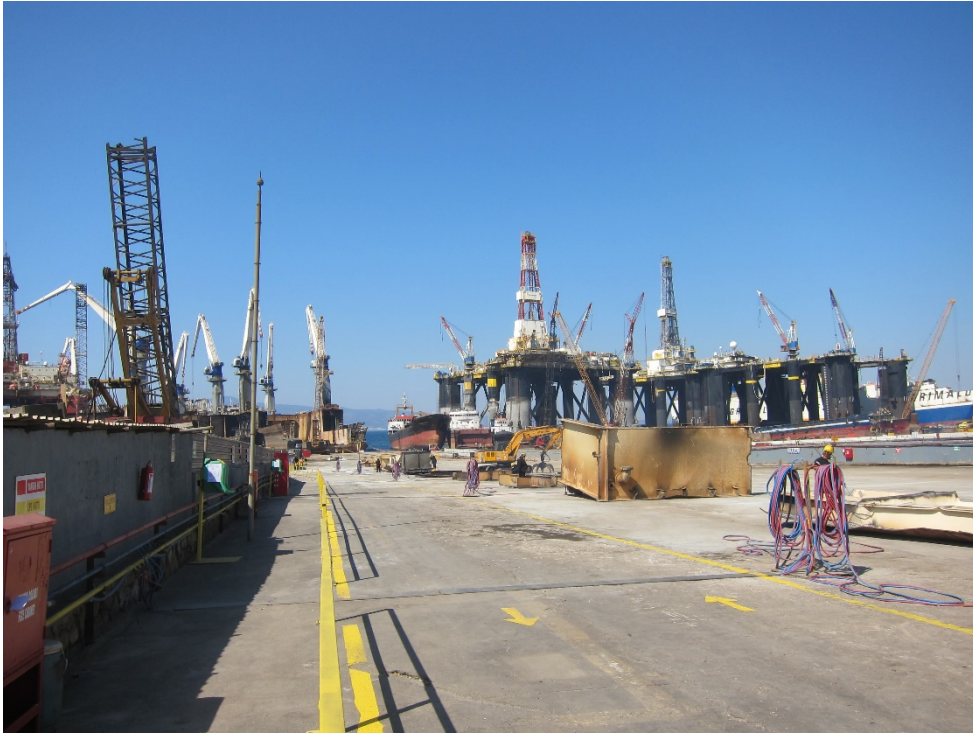
Clear access routes for firefighting and ambulances were observed on-site

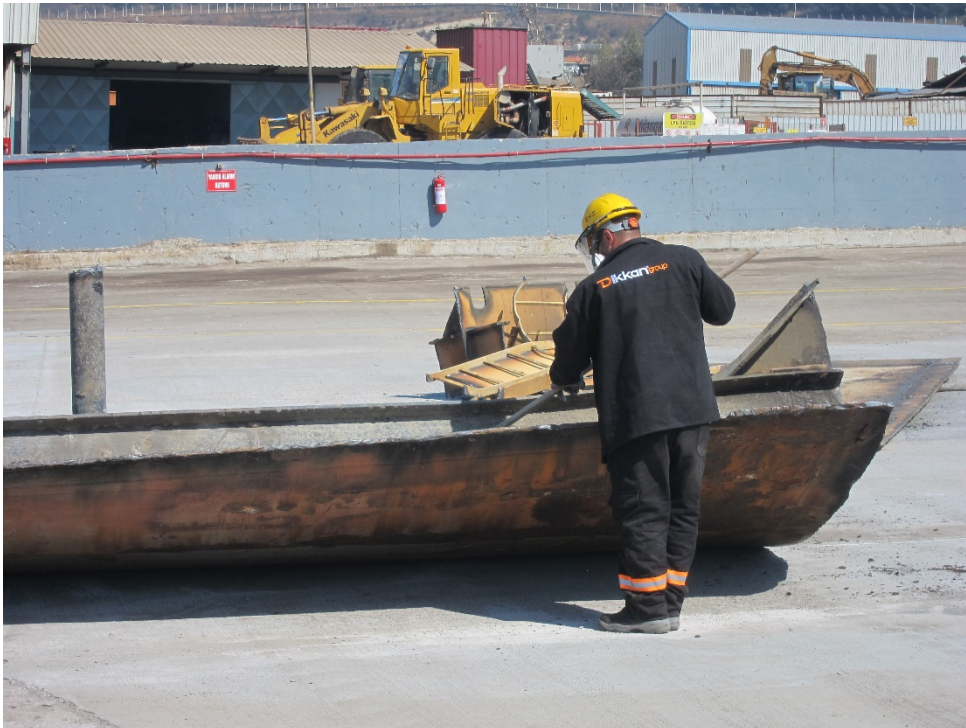
Helmets, shoes, eye protection, gloves and respiratory masks were worn throughout the operation.

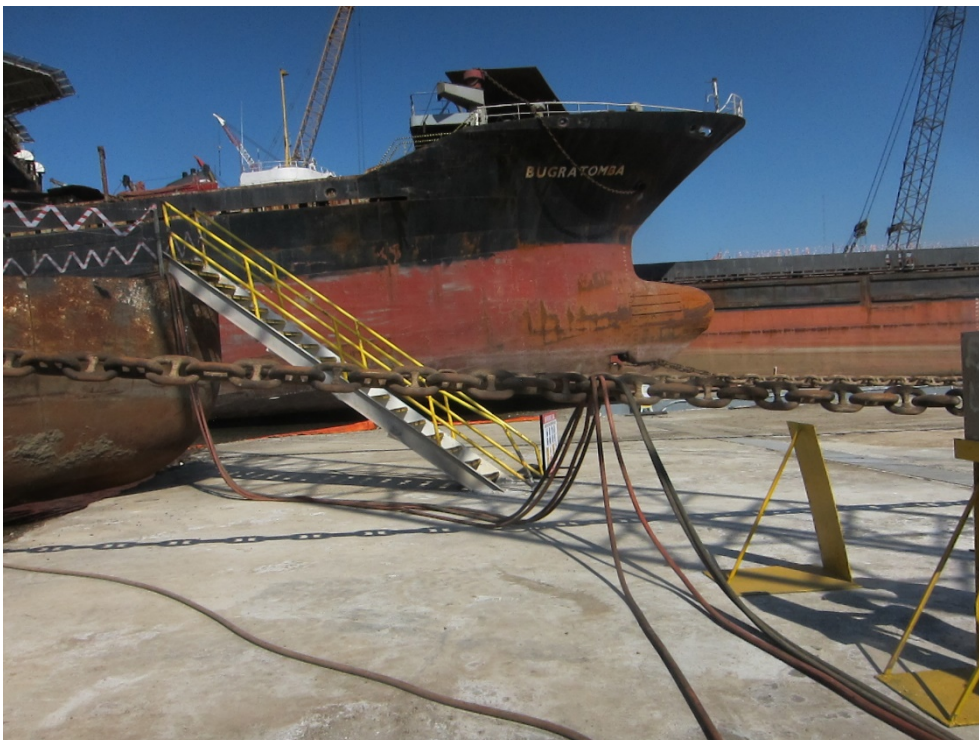
The evaluators observed access to the vessel under dismantling by ladder. Secondary access is by basket lifted by crane.

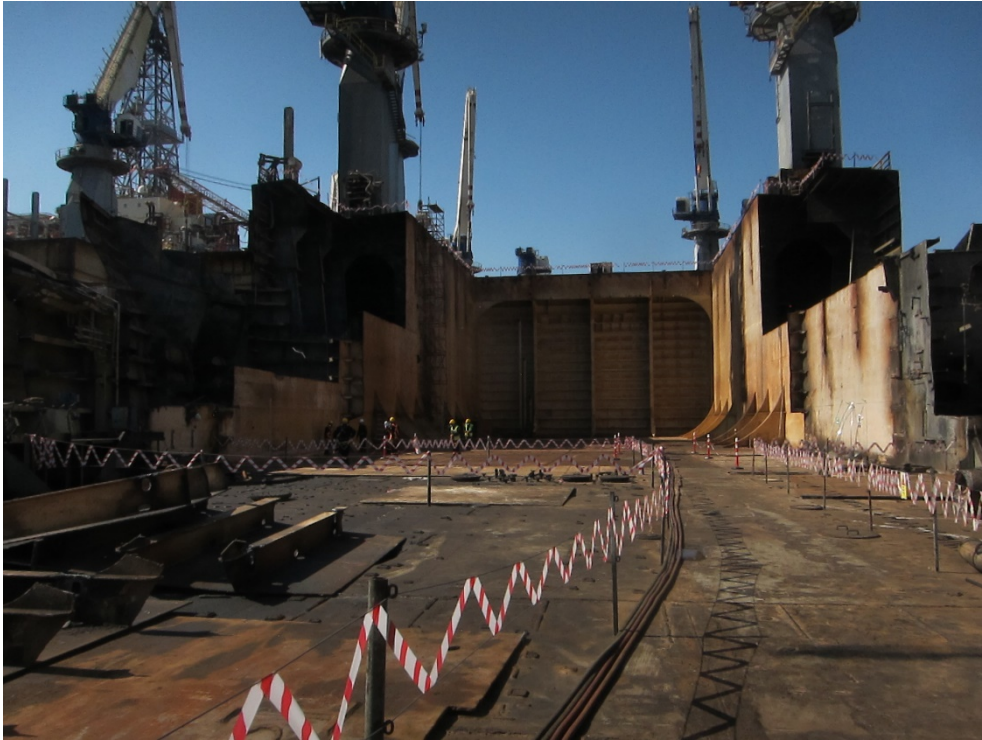
The vessel under dismantling was observed to have various barriers erected.

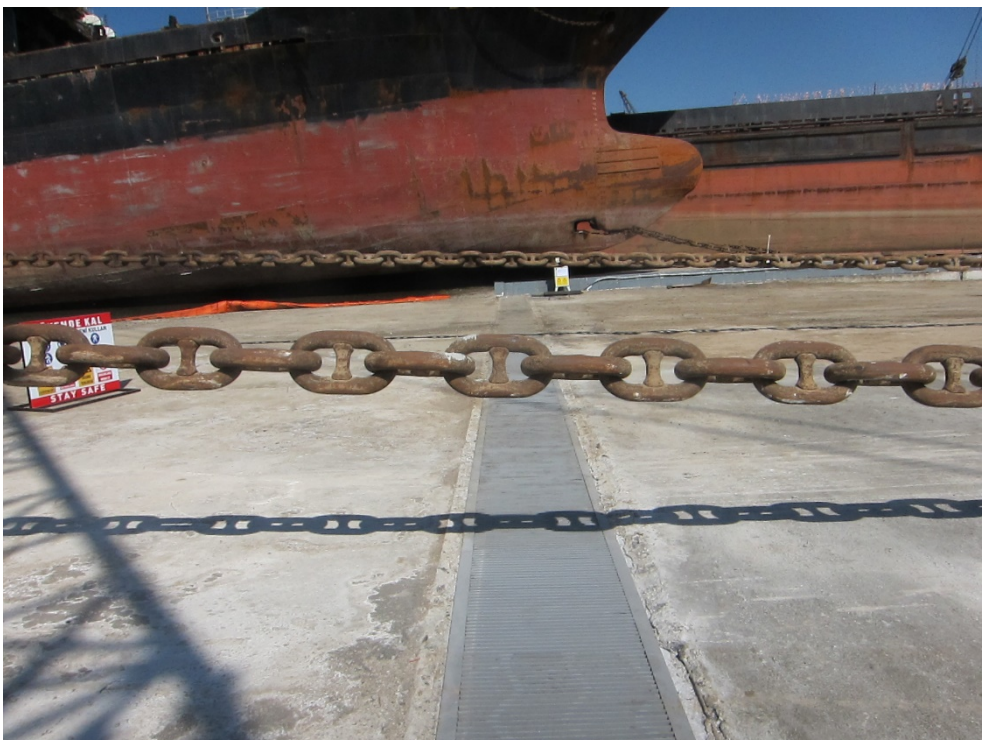
Drainage system runs across the plot. There are two drainage lines in the facility. A newly constructed drain line close to sea, and another a bit further from sea.

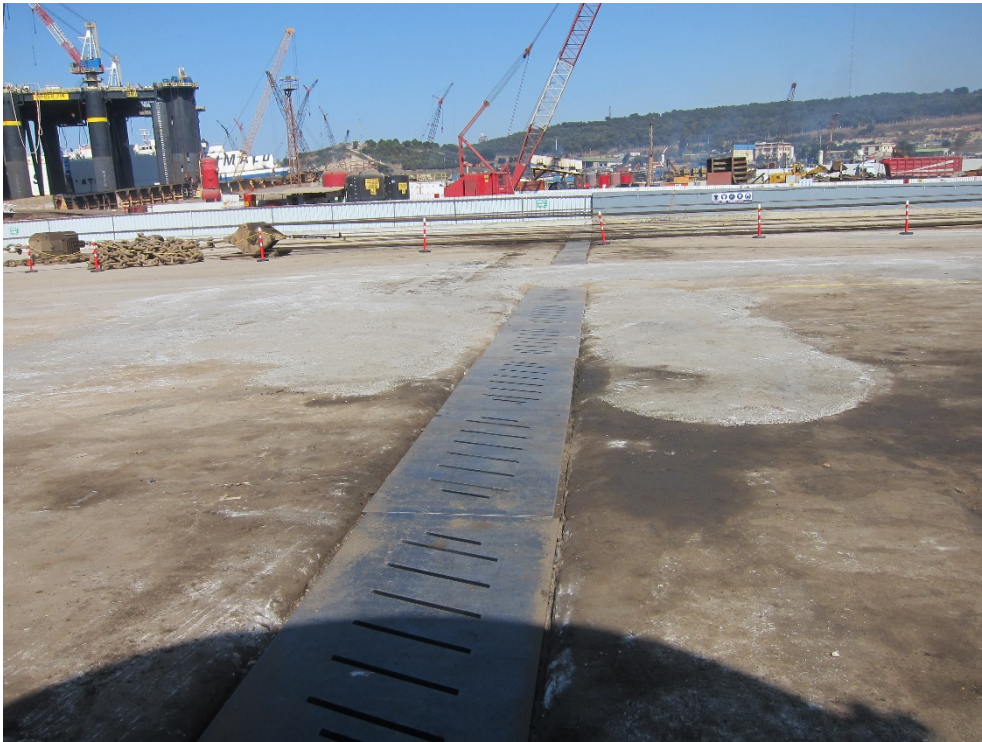
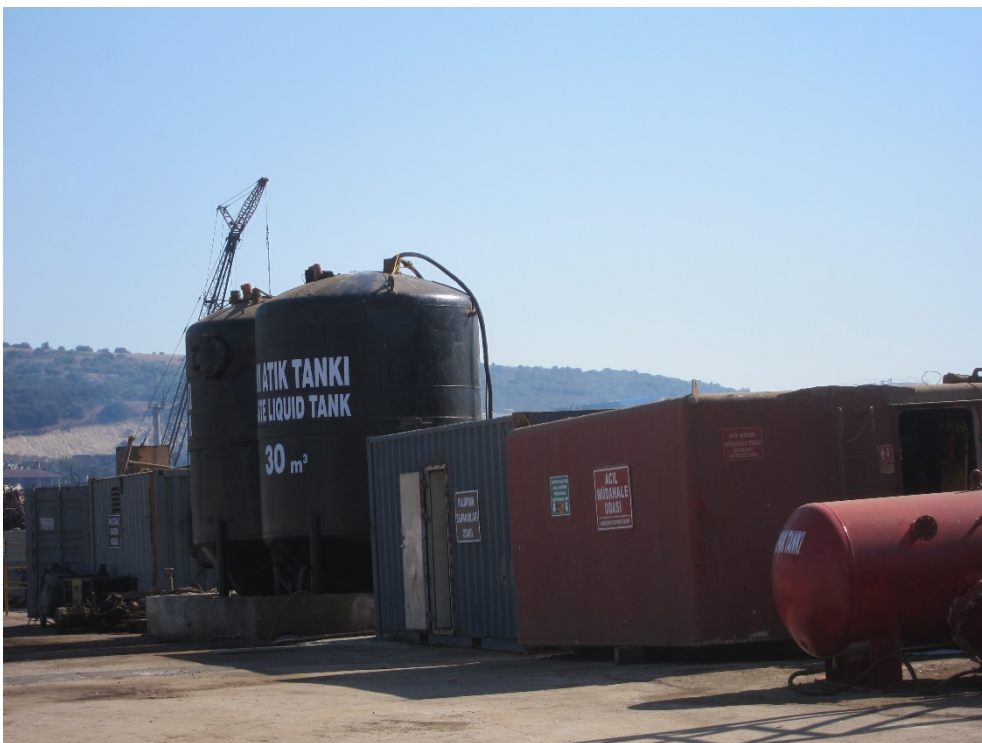
Water from the drain line is pumped into two tanks.

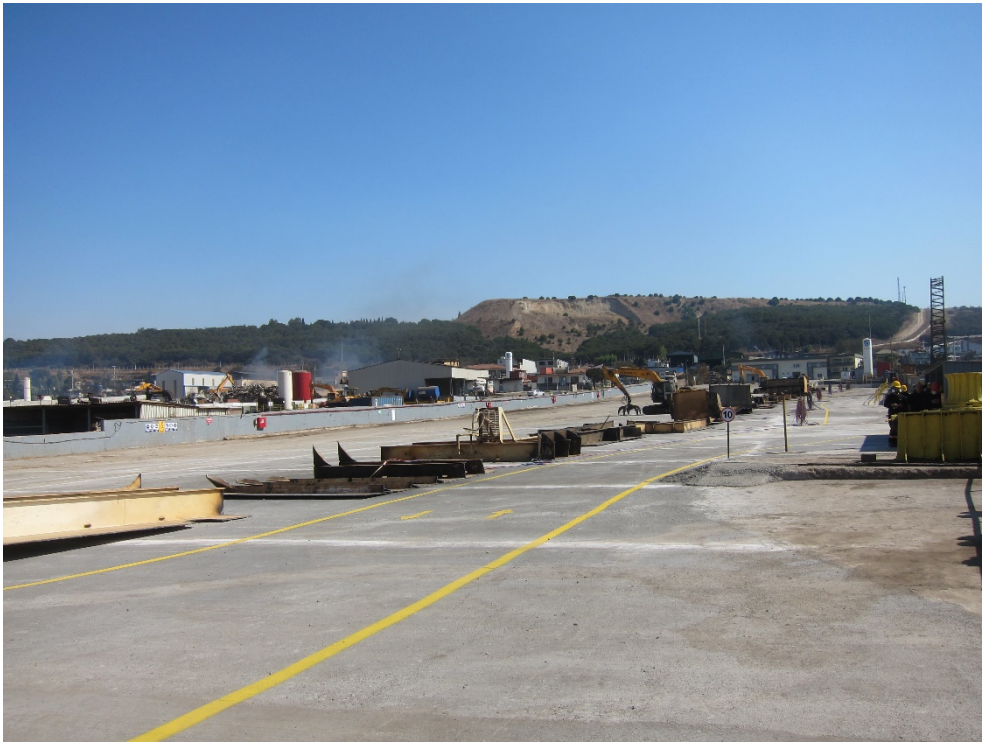
It could be established that the impermeable flooring was continuous

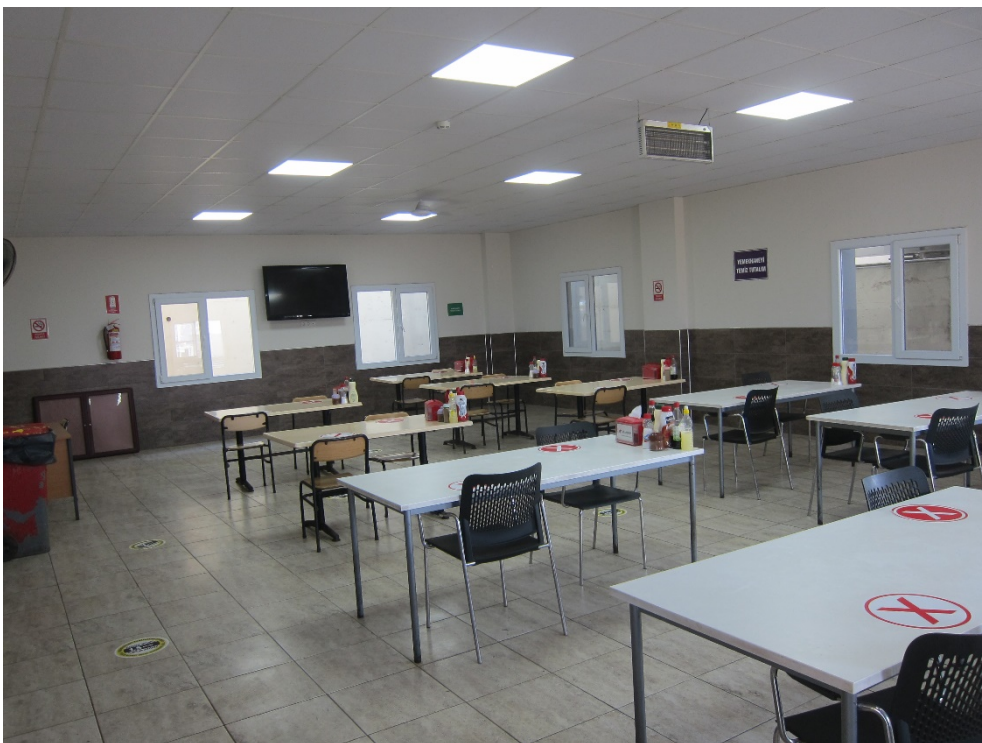
The workers had a canteen, sanitary and washing facilities and cloakrooms
