INSPECTION OF A SHIP RECYCLING FACILITY IN INDIA

Site Inspection Report Application 003

Report No.: 2019-0072, Rev. 2

Date: 2020-06-15

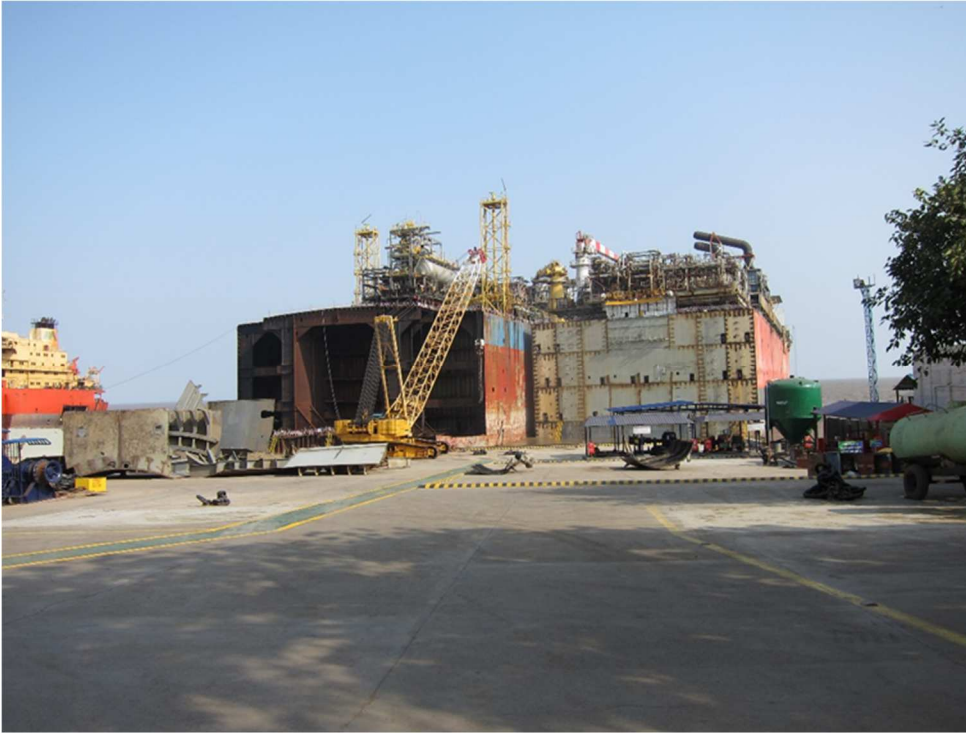
In the front yard, there are clear access routes for firefighting and ambulances.

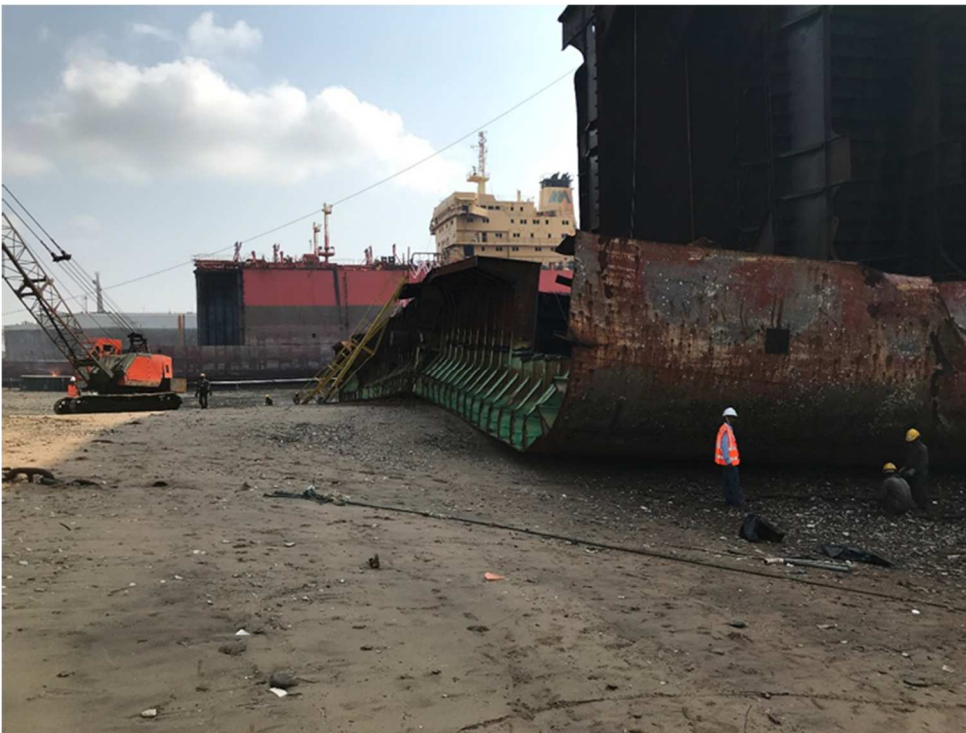
Crane operating in the intertidal zone.

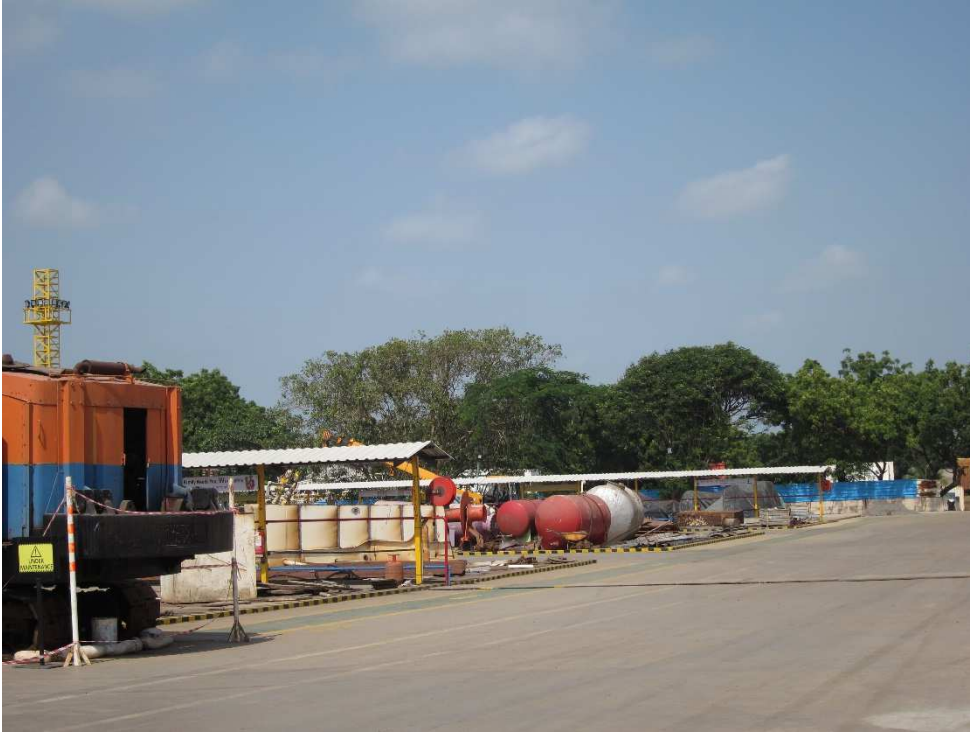
In the back yard, there are clear access routes for firefighting and ambulances.

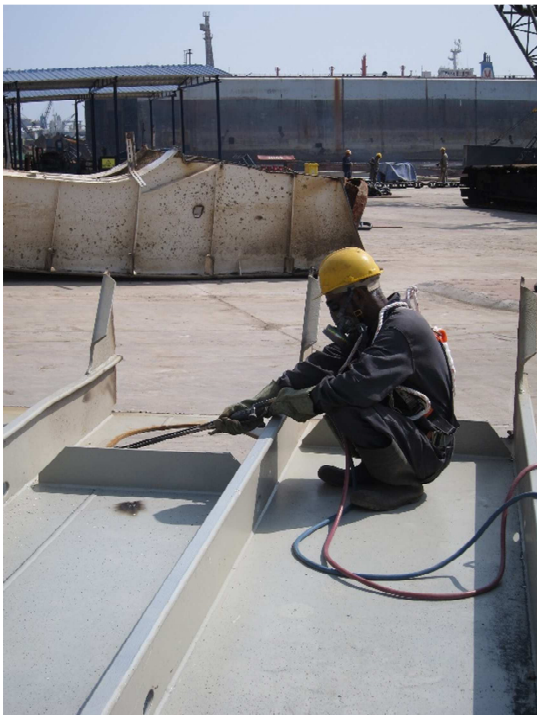
Helmets, shoes, eye- and respiratory masks was worn throughout the operation by cutters.

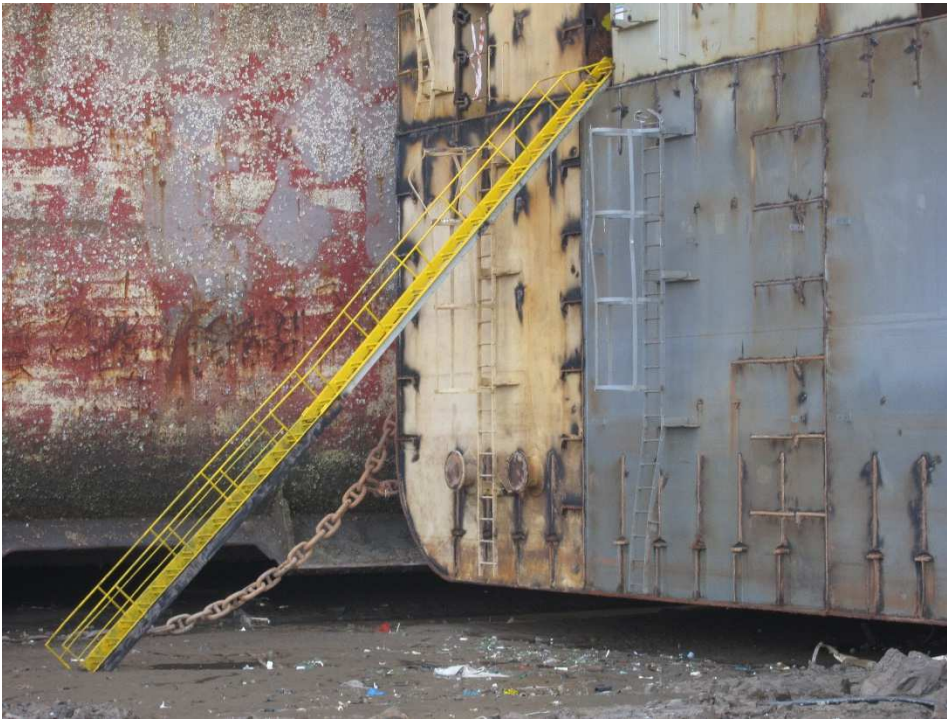
The facility normally uses stable stairs for regular access. Secondary (emergency) access is in way of basket and crane.

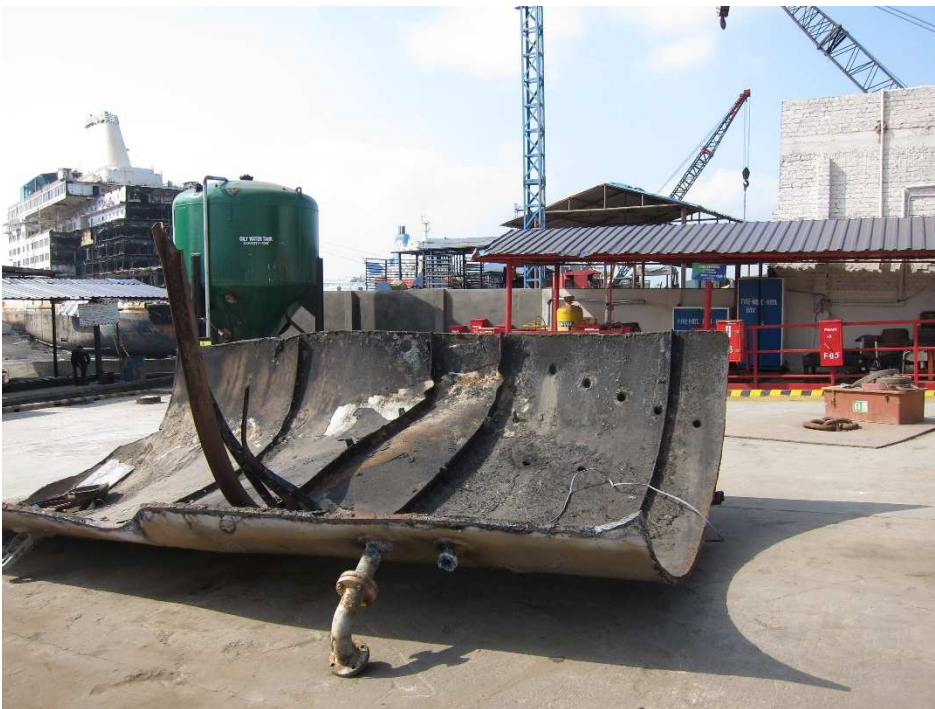
Secondary cutting area is on impermeable floors connected to a drainage system.

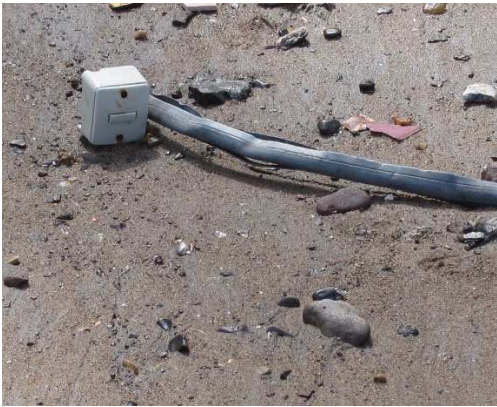
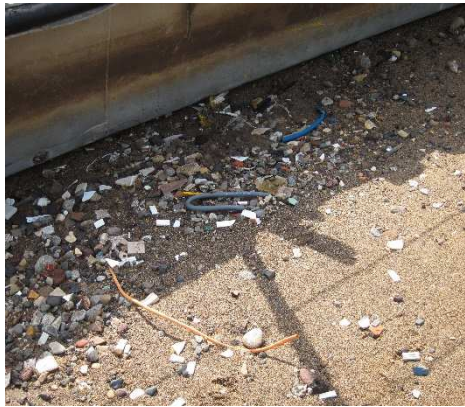
Debris, including electronic equipment were observed in the intertidal zone. It is likely that much of the debris originated from the neighbouring yard where a passenger vessel was being dismantled.

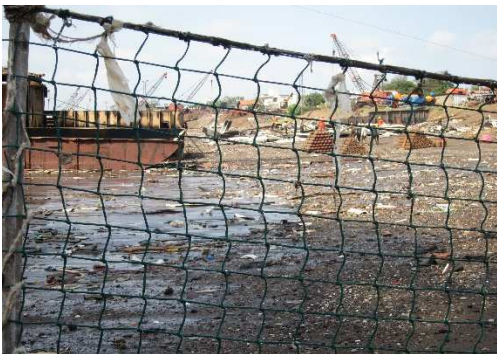
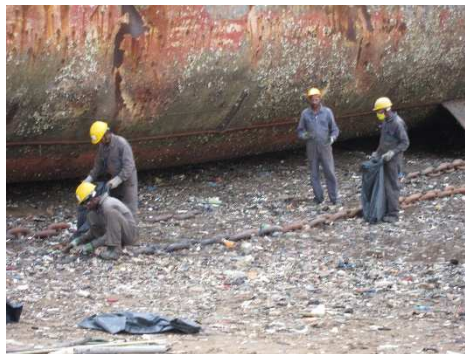
Neighbouring plot behind the netting fence. Waste handlers cleaning the intertidal zone.

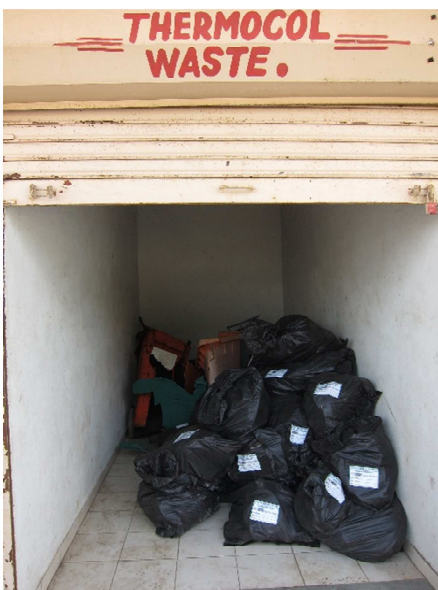
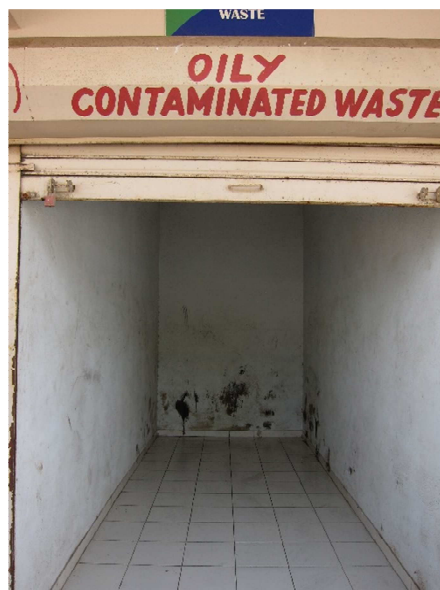
Hazardous waste was stored on impermeable floors, in locked rooms.

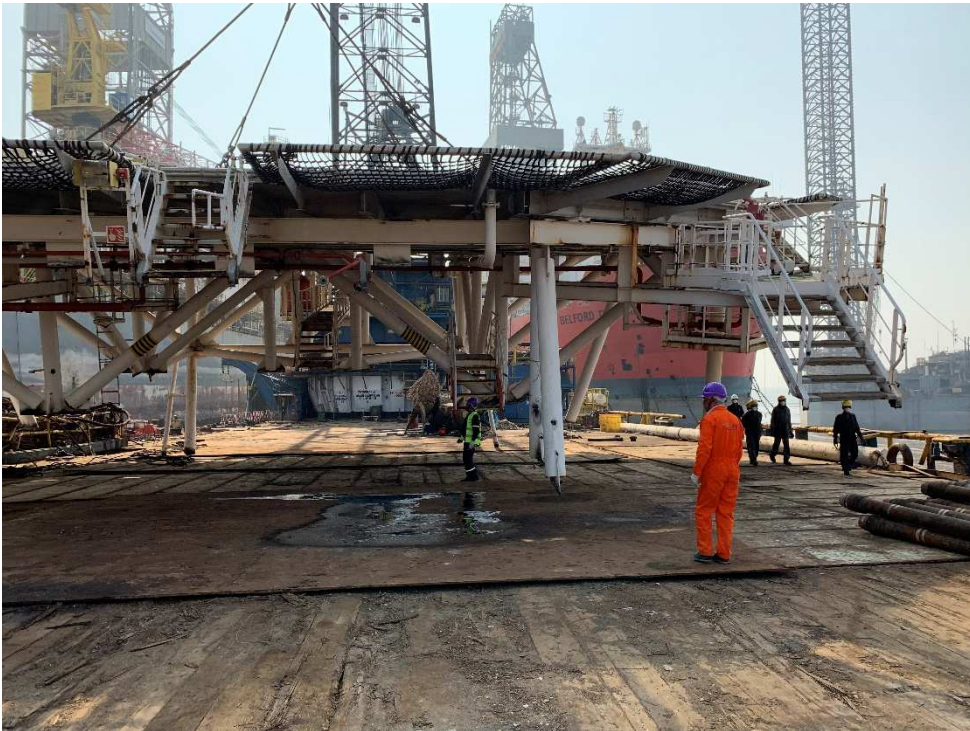
further information was received after the second inspection.	
	Impermeable floors	<p>During the first inspection, secondary and tertiary cutting areas were found on impermeable, reinforced concrete impermeable flooring. The applicant has impermeable floor that has been extended into the intertidal zone, with a clear drop of a couple of meters.</p> <p>It is unclear to the evaluators if permits for this extension were required by the Indian Coastal Zone Management law.</p> <p>During the second inspection, the applicant used the deck on a crane barge for secondary cutting. The barge was observed to have mainly wooden deck, partly covered in steel plates, observed with several oil spills. Impermeable floors on the barge do not appear to have been given the necessary level of consideration for the secondary cutting area of the crane barge.</p>	Compliance was partly confirmed during the second inspection.

Deck on the barge crane.
Wooden deck partly
covered with steel plates.
The deck is used for
secondary cutting.

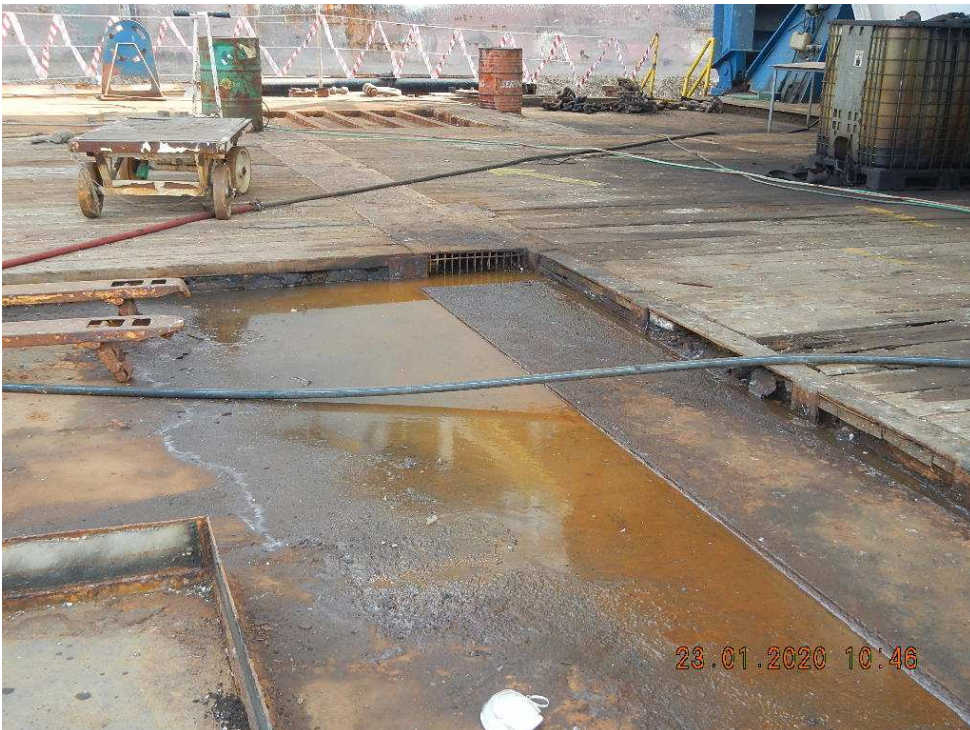
Prevention of adverse
effects on the
environment, including
drainage, do not appear
to have been given the
necessary level of
consideration.

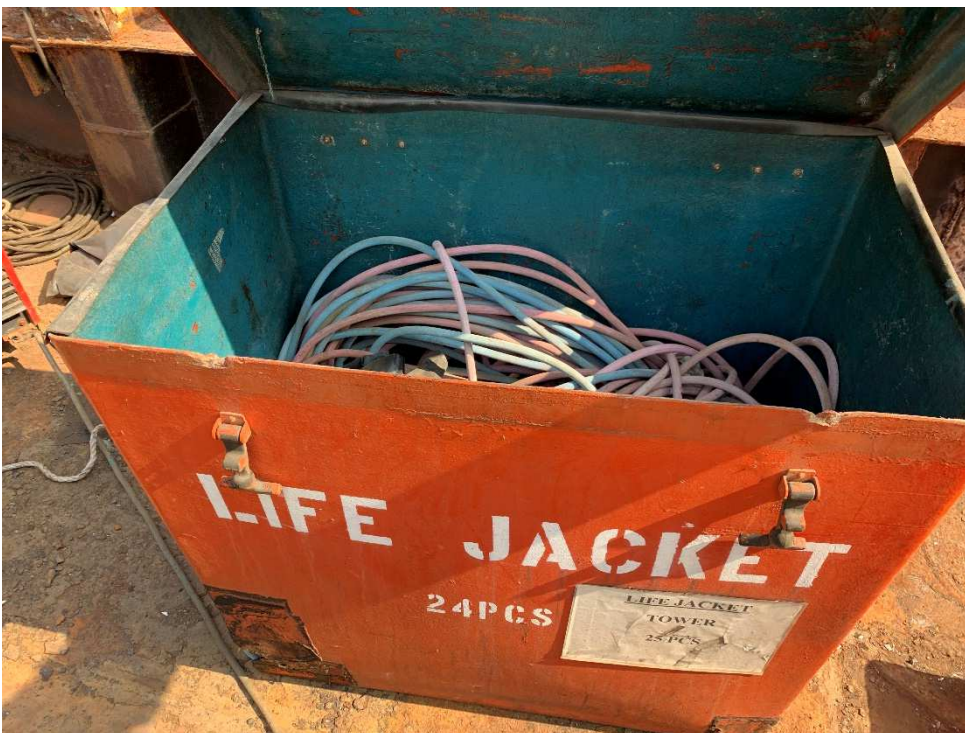
The regime for safety equipment onboard the crane barge needs to be reviewed and actions taken. For example, a container on the crane barge deck was identified as containing lifejackets but when opened was found to contain cables and hoses.

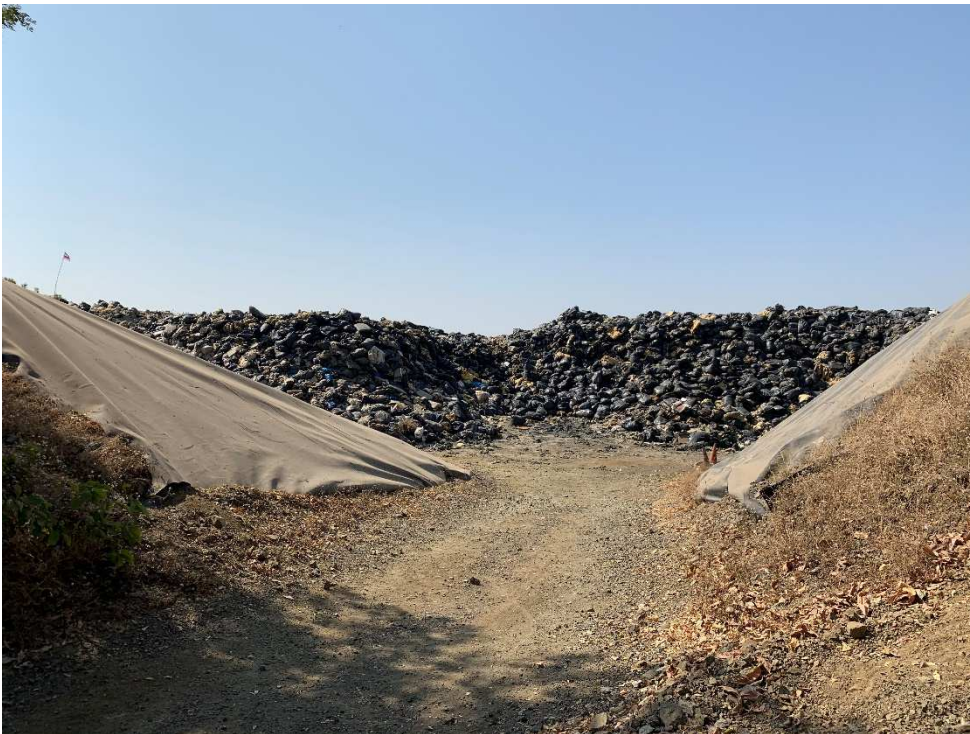
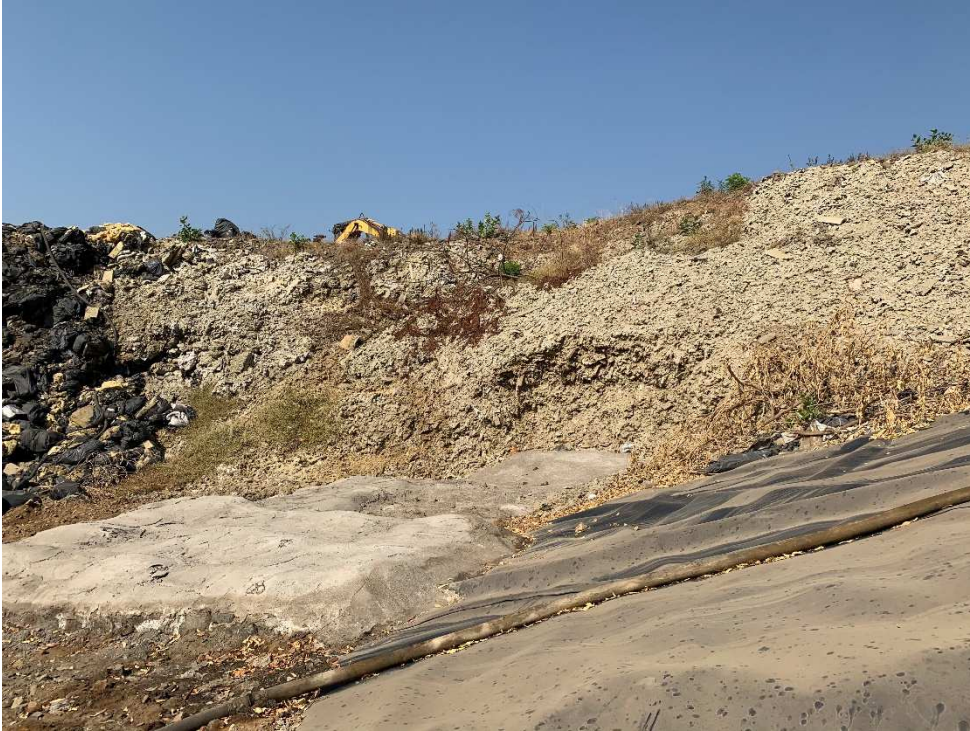
Landfill Cell 4.1:
Hazardous waste cell

<ol style="list-style-type: none">3. Cell 3 - Municipal solid waste - in operation4. Cell 4.1 - Hazardous waste cell – in operation5. Cell 4.2 - Municipal solid waste- not in operation <p>The permit includes a list of waste that can be landfilled and their quantities. It is understood that GEPIL does not receive any wastes which are non-acceptable according to the EU Landfill Directive.</p> <p>From the documentation provided by GEPIL on-site during the evaluators’ visit in September 2018, it appears that the landfill is constructed in a way to protect soil and water. The landfill has a geological barrier, leachate collection and sealing system. There is a leachate control well for each landfill cell. Specific requirements apply for capping the landfill with compacted soil, HPDE geomembrane, drainage layer, soil and vegetative layer.</p> <p>It is understood that waste disposed of at the landfill is pre-treated, except for asbestos. Asbestos and ACM are immediately covered in concrete in cell 4.1 which is a hazardous waste cell. Asbestos arriving at site shall be wrapped in two layers of plastic.</p> <p>The permit includes requirements for noise. The permit requires (point 5.9) that after closure of a cell, vents shall be installed and regular monitoring of the emission of the vent shall be carried out.</p> <p>The permit requires regular monitoring of ground water and ambient air quality. However, it does not specifically define within which intervals this regular monitoring is carried out. Some monitoring reports were witnessed on-site during the evaluators’ visit in September 2018. The evaluators understand that contracted third parties conduct monitoring and GCPB conducts regular and unannounced monitoring of GEPIL.</p> <p>Based on all the information currently available to the evaluators, it appears that the operation of the landfill likely follow standards broadly equivalent to international and EU standards.</p> <p>The operational landfill Cell 4.1 (Hazardous waste) is close to reaching its full capacity. It is</p>

Asbestos is solidified in
one corner of the landfill
cell.
