INSPECTION OF A SHIP RECYCLING FACILITY IN TURKEY

Site Inspection Report Application 005

European Commission DG Environment

Report No.: 2019-0255, Rev. 1 **Document No.:** 117PDS96-4

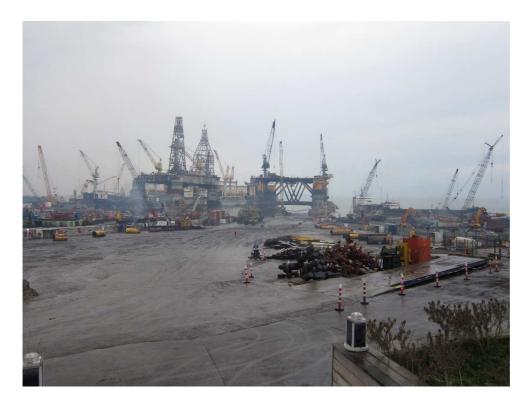
Overview over the facility from the office building.

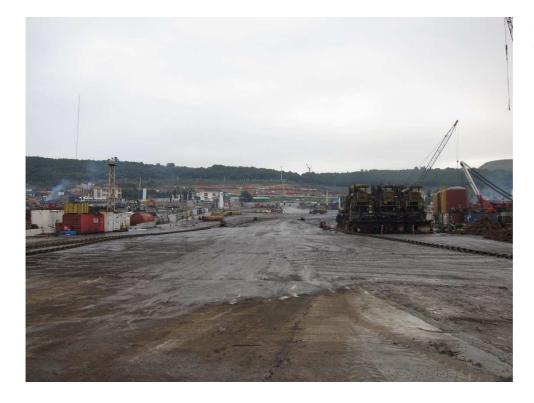
Clear access routes for firefighting and ambulances were observed on-site.

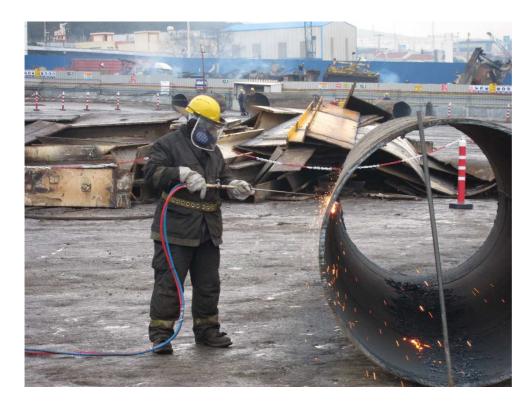
Cutters were observed to wear helmets, shoes, eye protection, gloves and masks with gas filters.

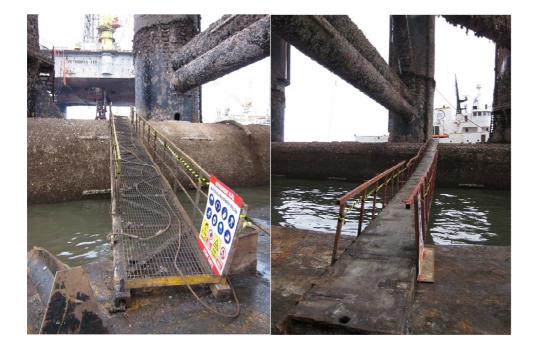
Access ways to the pontoons of the rig.

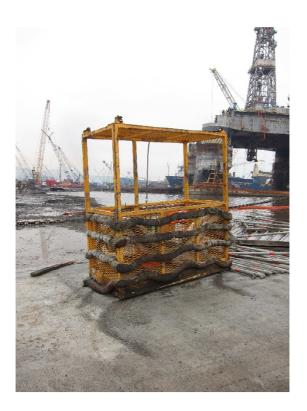
Secondary (emergency) access is in way of basket and crane, shore side.

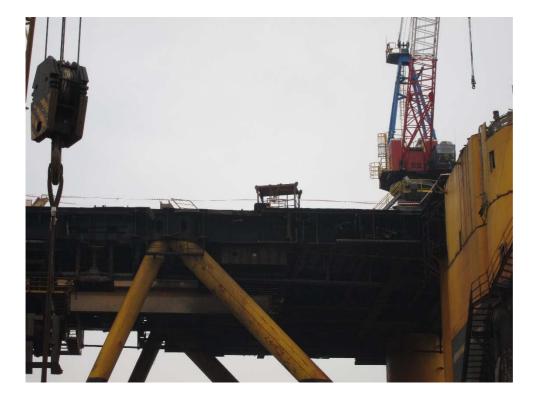
Secondary (emergency) access is in way of basket and crane, on rig.

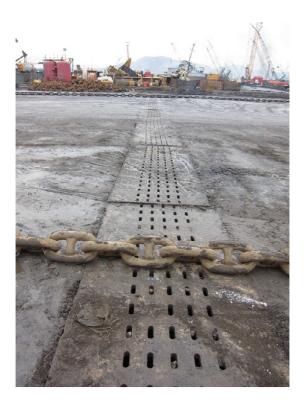
Drainage system runs across the plot.

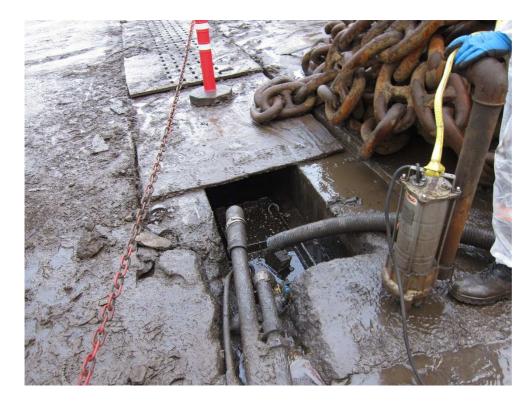
Drainage system pump was out of function.

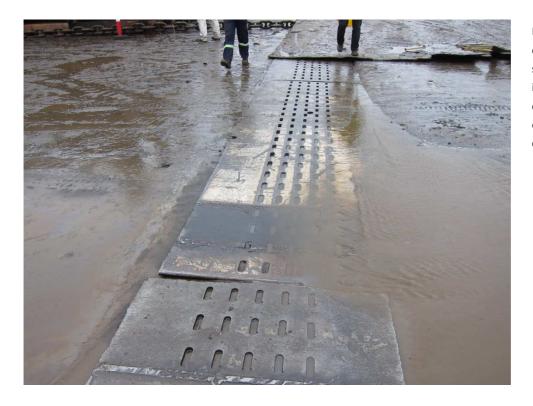
Technical guidance note 2.2.2, MEPC210(63) Section p34: 3.4.4.1	Drainage	It was raining during the site inspection. As mentioned above, the secondary cutting zone was unusually muddy, of which large quantities were ending up in the drain channel, filling it up. In a medium rain shower during the site tour on the second day of the inspection, the channel was overflowing. The drain pump did not work at the time. The applicant had initiated measures due to the failing pump. The facility has two drainage lines, one primary and one for emergency situations. It was apparent that when the primary drain was overflowing, it was flowing in a stream to the emergency drain line. The primary drain line where again pumped into trucks from SRAT. SRAT trucks were also observed to pump out drained water directly from the emergency line. The evaluators observed that the water remained in the emergency drainage system. Although the drain water collection tanks had high capacity (4 x 55 m³), the pump was observed to be very small. The drain channel was reportedly cleaned out by excavator regularly, the entire area was reportedly cleaned weekly. The facility promised to rectify the situation, looking at the handling capacity of the entire system. The applicant was requested during the site inspection to confirm what they have done to rectify the situation, supported with photographic evidence. In response to the draft report the applicant forwarded two photos and a video of the drainage system (drainage system 1.jpg, drainage system 2.jpg, and drainage video.mp4). The drainage pump has been replaced with a pump with a capacity of 80 m³/hr, organic mud filter and an electrical control panel to avoid circuit break failures, all shown in the forwarded video and photos. Based on the additional documentation received, the replaced pump is working, and the drainage system is found adequate.	Compliance was partially confirmed during the site inspection. Compliance was confirmed in response to the draft report.

Primary drain line overflowing on the second day of the inspection, but water is collected in the emergency drain line closer to the seafront.

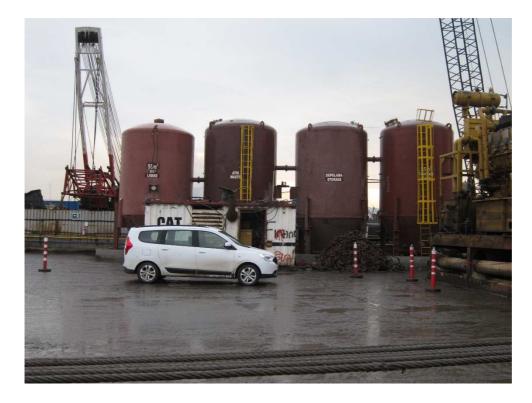
Storage capacity for drained water.

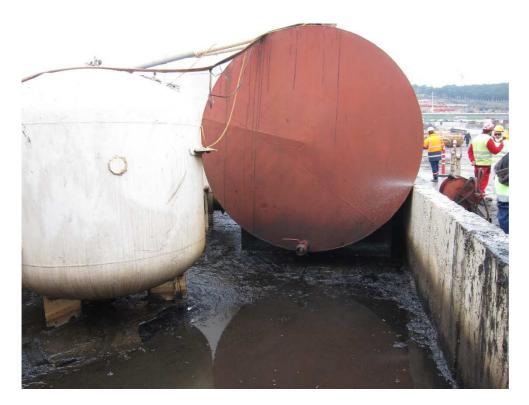
Puddles in the mud were observed with oily water. The ground inside the tray around the fire water tank was very oily and partly covered in a puddle, with a pungent smell of oil. It was not clear where the oil originally came from. The areas around the fire water tank

Accumulated sediments in the enclosure of the firefighting water tank, with a distinct smell of oil.

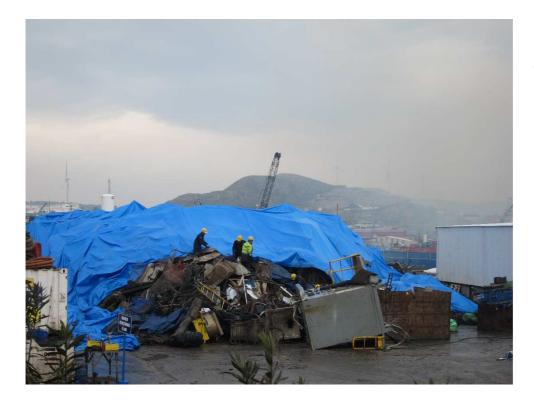
Technical guidance note 2.1.4, 2.2.2, 2.2.3, 2.2.5, 3.5, MEPC 210(63) Section 3.4.2.5 / BC TG 3.1, 3.3,	Waste storage	The facility stores materials on site to be further dismantled to separate the metal from the remaining of the product. The material is stored on concreted flooring with drainage. Other waste materials are transported directly to waste management facilities. It was observed on site that the pile of waste was covered with tarpaulin when it rained.	Compliance confirmed during the site inspection.

Pile of waste to be separated covered with tarpaulin.

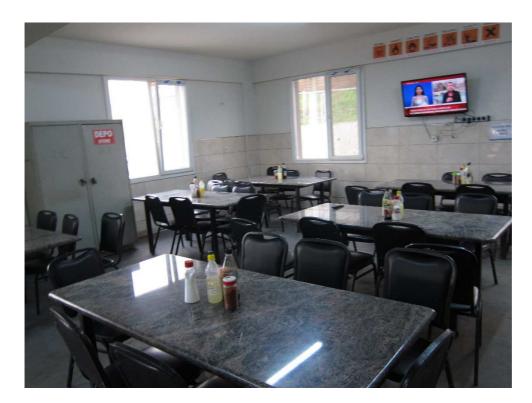
Canteen where workers are served hot lunch every day.
