INSPECTION OF A SHIP RECYCLING FACILITY IN INDIA

Site Inspection Report Application 006

Report No.: 2019-0050, Rev. 2 **Document No.:** 117PLW2Y-5

Date: 2020-05-08

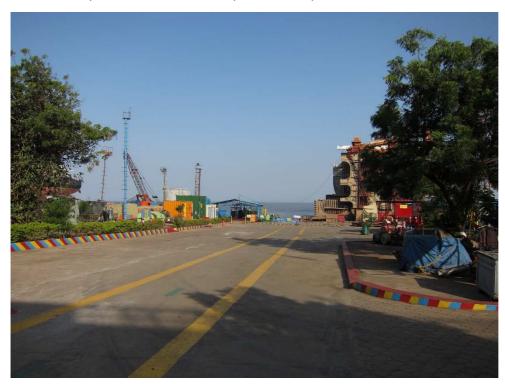
Front yard. Clear access routes for firefighting and ambulances were observed on-site.

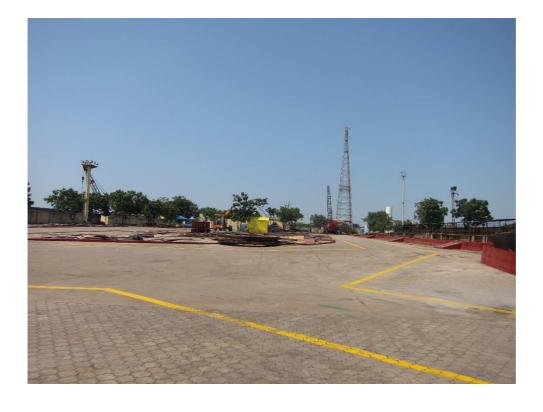
Back yard. Clear access routes for firefighting and ambulances were observed on-site.

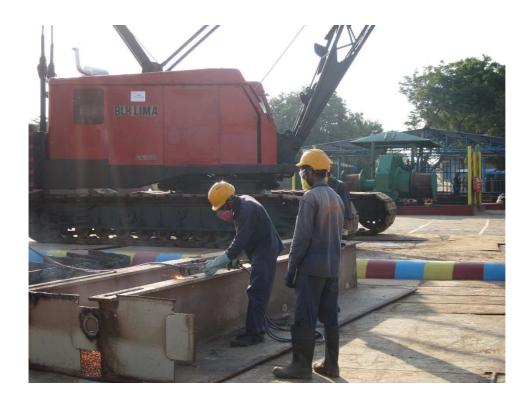
Helmets, shoes, eyeand respiratory masks were worn throughout the operation by cutters. The helpers were similarly equipped, except for the masks.

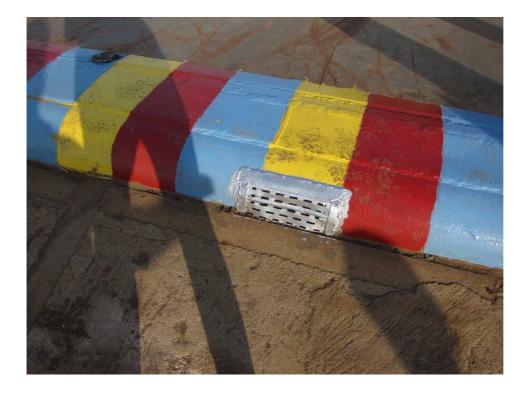
First inspection in the front yard. In some cases, the drain strainers were deemed small. The facility reported that there was no problem with overflow.

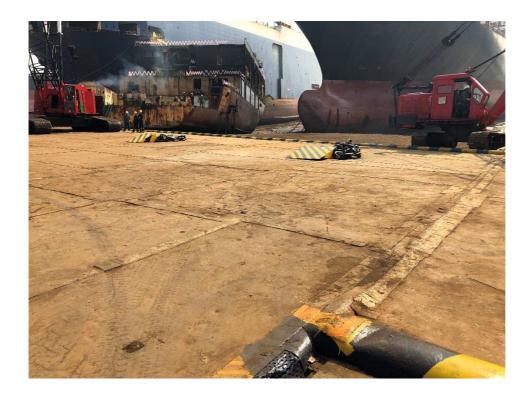
Second inspection the drain holes were
considered small and
scarce and the
coaming height
rather low. Question
if this could
accommodate worst
case rainfall.

This was rectified after the second inspection.

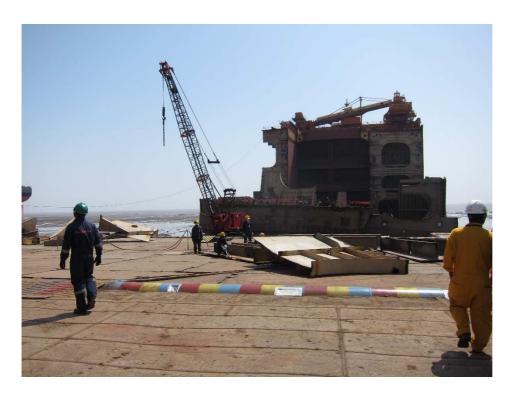
Secondary cutting area is on impermeable floors connected to a drainage system. There are two drainage lines. One on the sea front and one further away from shore which is seen here.

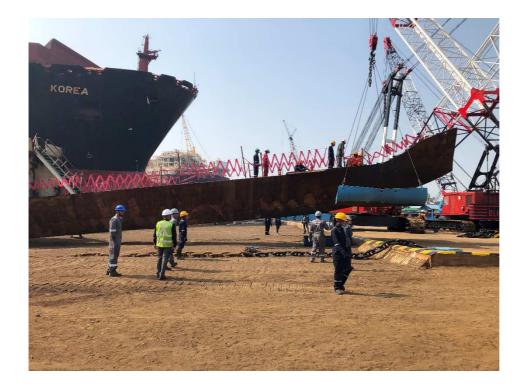
Second inspection – the double bottom was cut above impermeable floor with drainage.

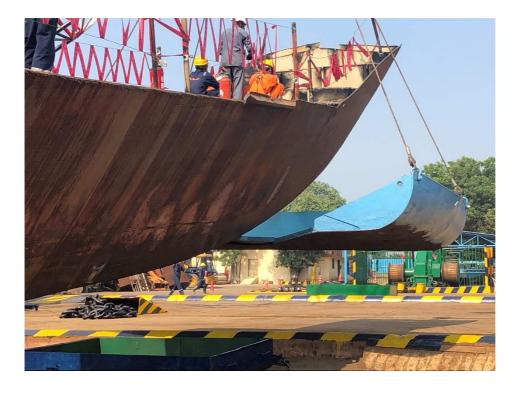
Second inspection – the double bottom was cut above impermeable floor with drainage.

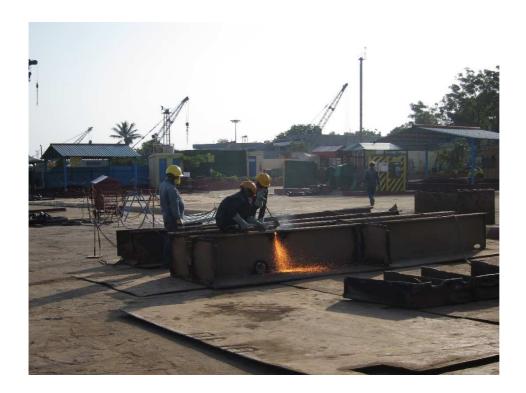
Secondary cutting on impermeable floor with drainage.

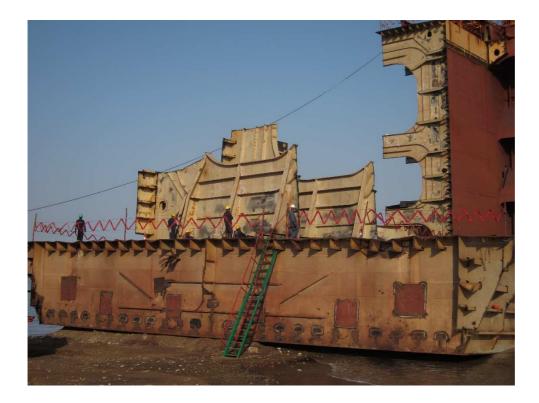
Access to ship by stable stairs.

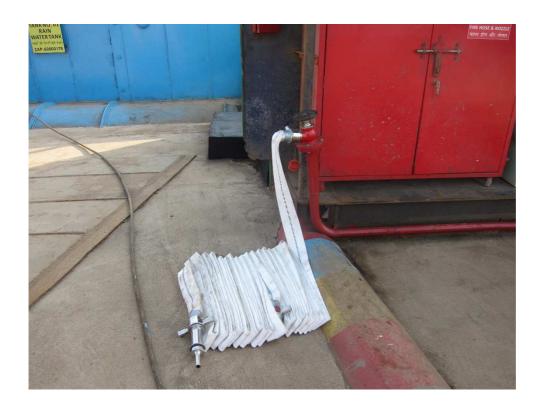
Firefighting hoses in good condition.

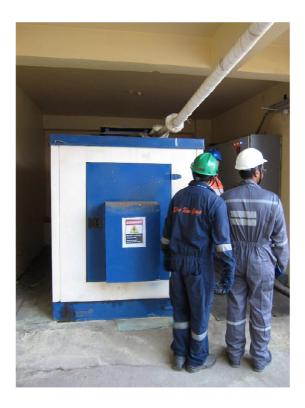
Almost new generator.

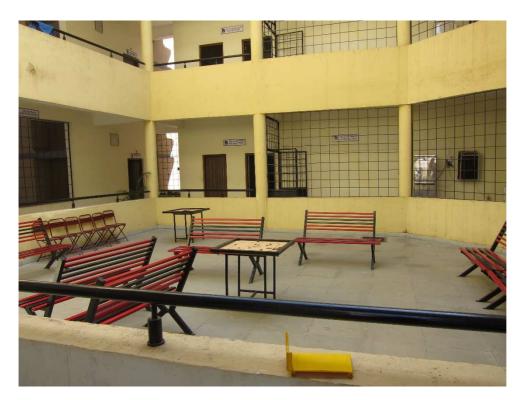
Recreation area in the workers colony operated by the GMB. Not used by workers from the yard subject to this report

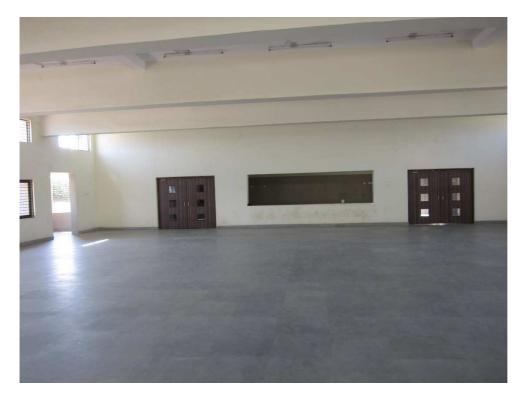
The common kitchen and dining area.
Currently not in use because there are few workers living in the colony.

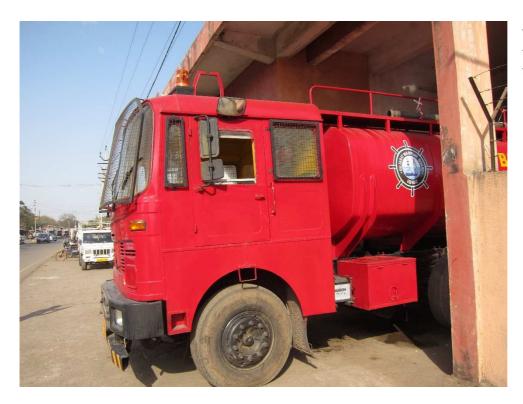
The two operational firefighting vehicles at the Fire Station in Alang.

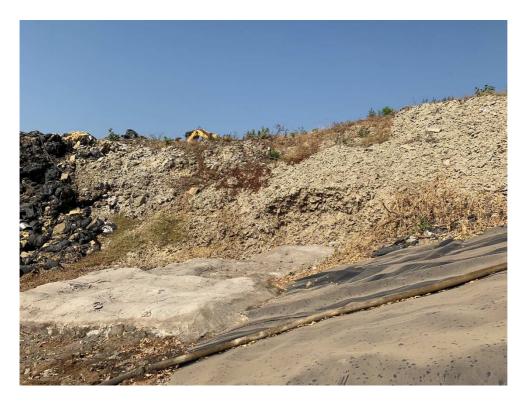
Landfill Cell 4.1: Hazardous waste cell Asbestos is solidified in one corner of the landfill cell.
