INSPECTION OF A SHIP RECYCLING FACILITY

Site Inspection Report Application 27

European Commission DG Environment

Report No.: 2019-1221, Rev. 0 Document No.: 11GH3AWB-2

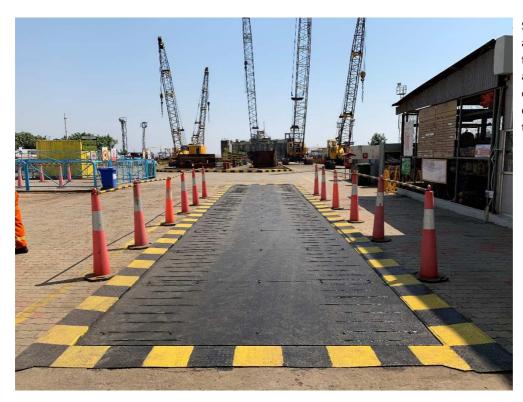
Single yard facility. Clear access routes for firefighting and ambulances were observed on-site. Provided cranes are not obstructing the routes.

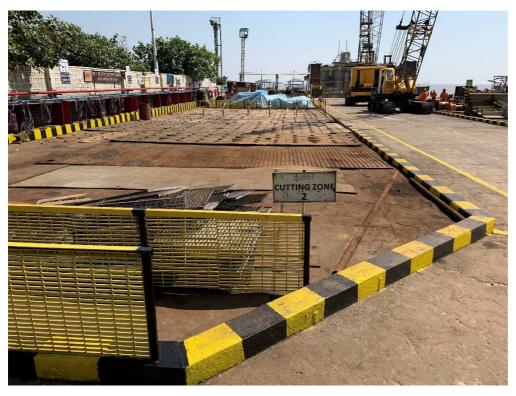
Oily cutting zone, clear segregation from crane movement zone, with 100mm high curbing marked in black/yellow.

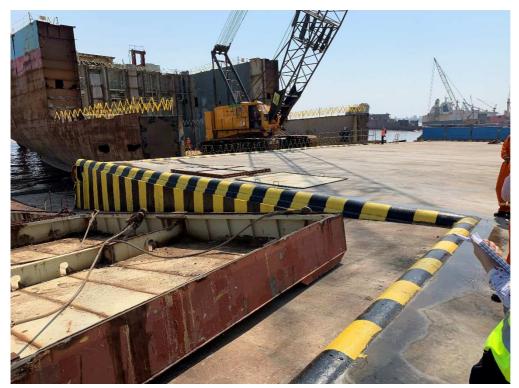
The facility has a parapettype interface with the inter-tidal zone. Drainage is provided by way of hollow pipes with cut-outs allowing ingress of water from the concrete impermeable surface.

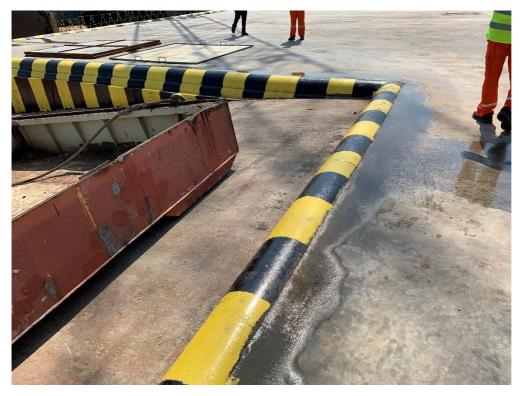
- 4. <u>Drainage system</u>: The effectiveness of the drainage system for the secondary cutting zone was questioned. The facility was asked to review the drainage system arrangement, perform calculations and tests to demonstrate the capacity of the systems and incorporate any modifications found to be necessary.

It was observed that the height of the drain lip above the concrete surface was very low in places, and that with few inlets to the drain the ability of the drainage system to handle the expected rainfall and any liquid waste is questioned.

The facility advised that the drainage system in the areas would be revised to ensure adequate drainage was provided. No documentation was provided to demonstrate the effectiveness of the current drainage	guidance note 2.2.2, MEPC210(63) Section p34:	Drainage	It is a requirement that the handling of all hazardous material generated during the ship recycling process only shall be conducted on impermeable floors with effective drainage systems. The facility has recently redeveloped the secondary cutting zone, replacing steel plates with concrete. It was seen on site that as a result the effectiveness of the drainage provided for the secondary cutting area has been compromised. The drainage system consists of hollow pipe fenders with drain slots cut out, these are covered by a light gauze to prevent debris entering the drain. The deficiencies noted were that the height difference between the top of the concrete and the top of the pipes was almost non-existent in some areas, and that the number and size of the drain slots did not seem sufficient to cope with the possible volumes of rain that may be expected. The facility was asked to review the drainage system arrangement, perform calculations to demonstrate the capacity of the systems and incorporate any modifications found to be necessary. The facility advised that the drainage system in the areas would be revised to ensure adequate drainage was provided.	partly confirmed during the

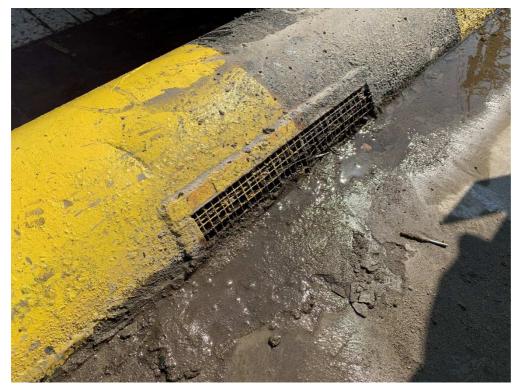
Close up of drain hole. The ability of the drainage system to handle expected water volumes is yet to be demonstrated.

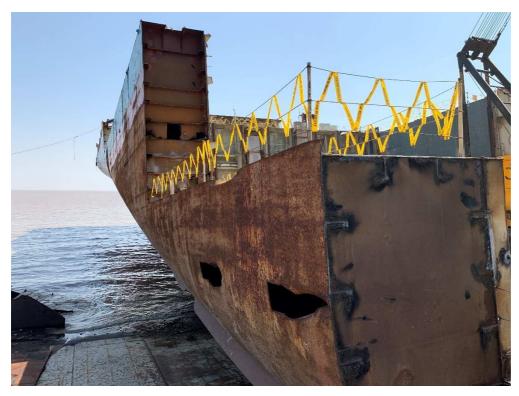
The facility was in the process of dismantling a ship during the site visit. Barrier warning tape was seen in place. Temporary steel plate bulkhead was seen to employed to prevent ingress of water during high-tide. The steel plates covering much of the inter-tidal zone can be seen.

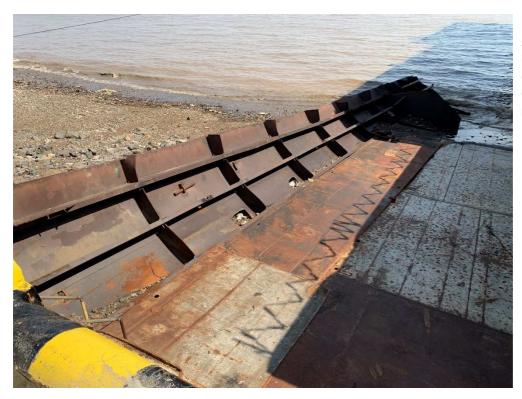
The facility has installed steel plating (remnants of formerly recycled ships) in the intertidal zone, this is acting as a quasi-impermeable floor – since there are both some small holes at several locations in the plates and a larger hole in the area under the keel of a vessel when centrally located on the plot. The evaluators observed that while these steel plates did provide an additional barrier and were considered a positive enhancement; however, they did not constitute an impermeable floor as defined by the EU Ship Recycling Regulation. On-site the applicant advised that they may consider how they could modify the steel plates in the intertidal zone to fully comply with the requirements.

It can be seen that the steel plates protect the inter-tidal zone to some extent, however no drainage system is provided.

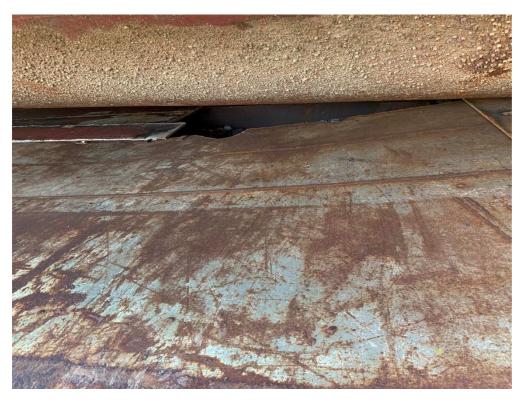
under the keel of the ship being dismantled it could be seen a hole in the steel plates.

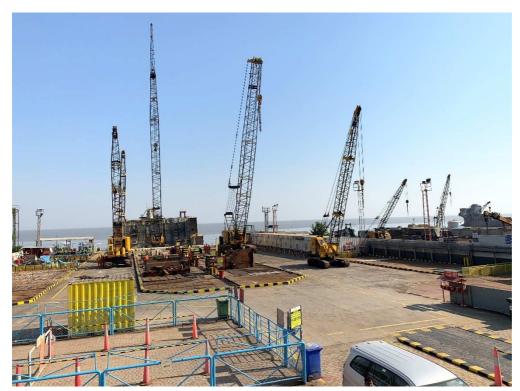
The facility is a single-yard operation (all activities are performed on the plot – with no back-yard)

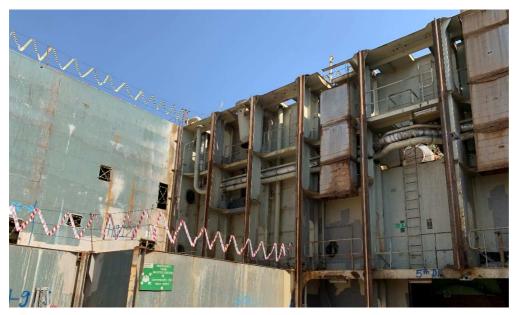
The ship being dismantled was generally found to be clean and tidy, with good signage and barriers in place.

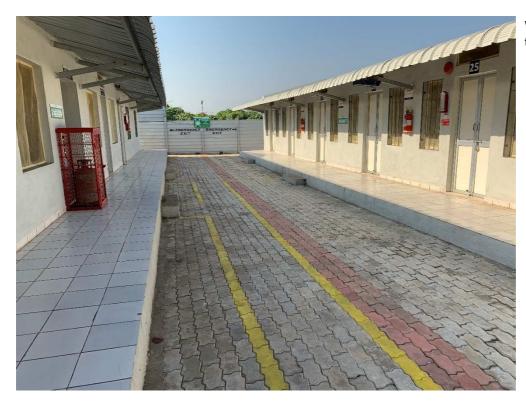
Workers' dormitory was found in good condition.

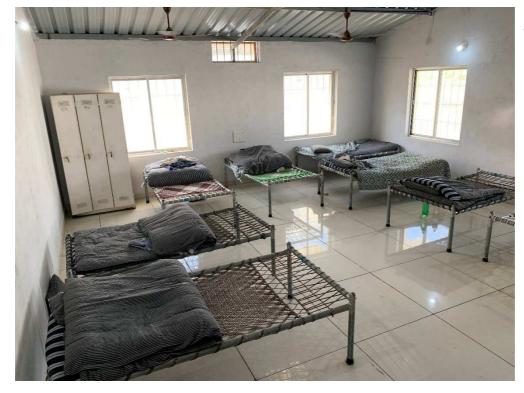
Rooms were clean and well ventilated.

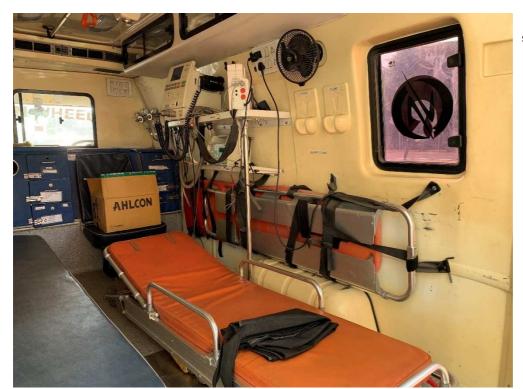
The facility's ambulance service.

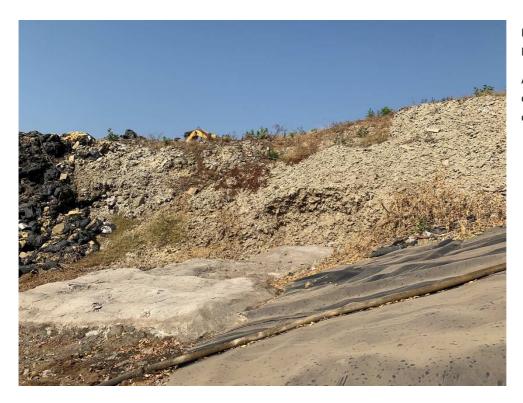
Landfill Cell 4.1: Hazardous waste cell Asbestos is solidified in one corner of the landfill cell.
