Community Civil Protection Mechanism European Commission

UKRAINE - Oil Spill in Kerch Strait, Black Sea

Final Report

November 2007

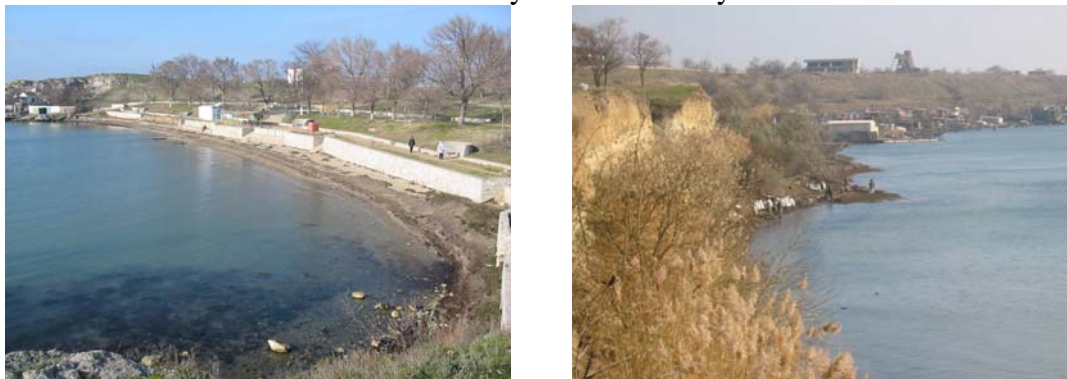
This part of the coast is made up of cliff of friable limestone rock varying from 4 to 10 metres in height. At the foot of these cliffs, the shoreline consists of a series of small sandy coves from 3 to 4 m wide with some friable and porous stone. The sediment consists of sand and dead shell.

The traces of visible pollution are very limited with some slightly contaminated algae and rocks. From the physical survey carried out by the experts, the pollutant appears to be heavy fuel oil in the range of IFO 280 and IFO 600. It is a heavy fuel oil of average viscosity but uncharacteristically it remains soft and is easy to clean off tools and hands (low adhesion).

The cove is located at the exit of the city and has already been 90% cleaned.

Figure 3 - Panoramic view of the Cape Karantynny coast

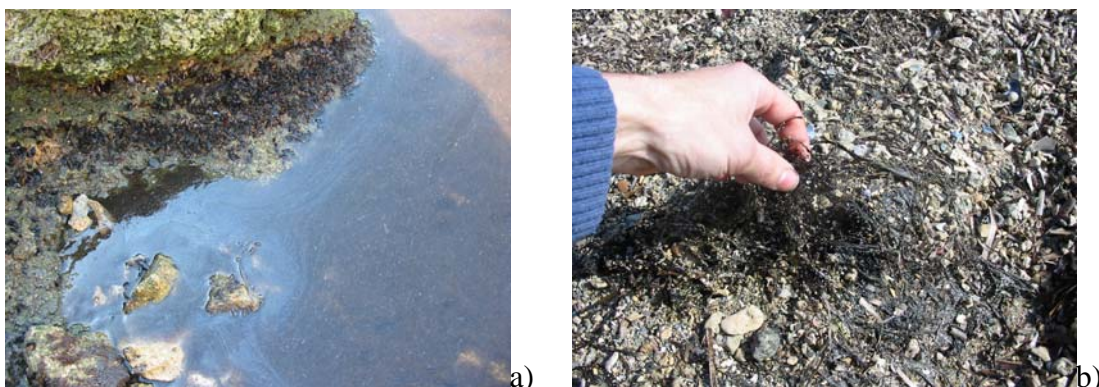
Figure 4 – a) oil sheen in water; b) sea plants polluted by oil

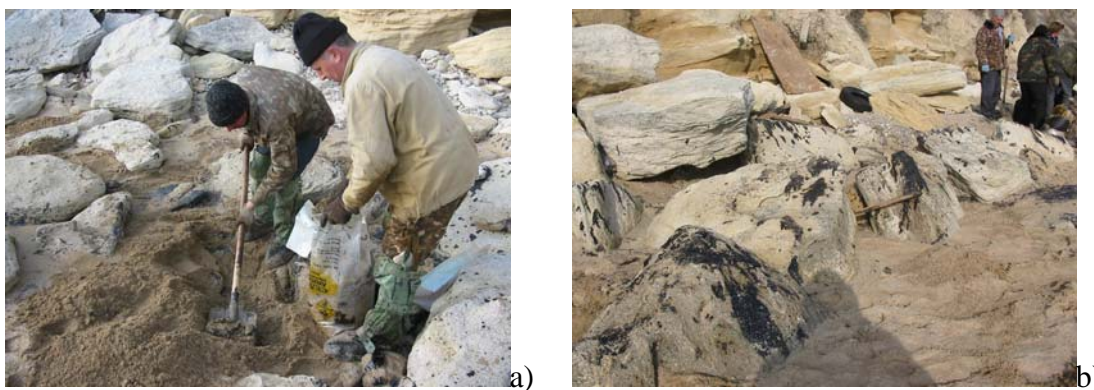
The recovery operations are being done manually using shovels. Approximately 30 operators were present on a stretch of 100 metres.

The collection of oil-polluted sand using shovels results in a high ratio of sand to oil. The bags of waste weighing 20-40kg were being carried manually to the top of the cliff.

Figure 5 – a) oil/soil mixture collecting activities; b) oil polluted rocks

- It would be possible to improve selectivity by using forks of the type used following the Prestige and Erika accidents and to use shovels only to remove the unpolluted layers of sand;

- Preliminary rinsing with water of the polluted sand using fire hoses would allow access to the polluted amalgam and also increase selectivity thus decreasing the percentage of sand in the waste;

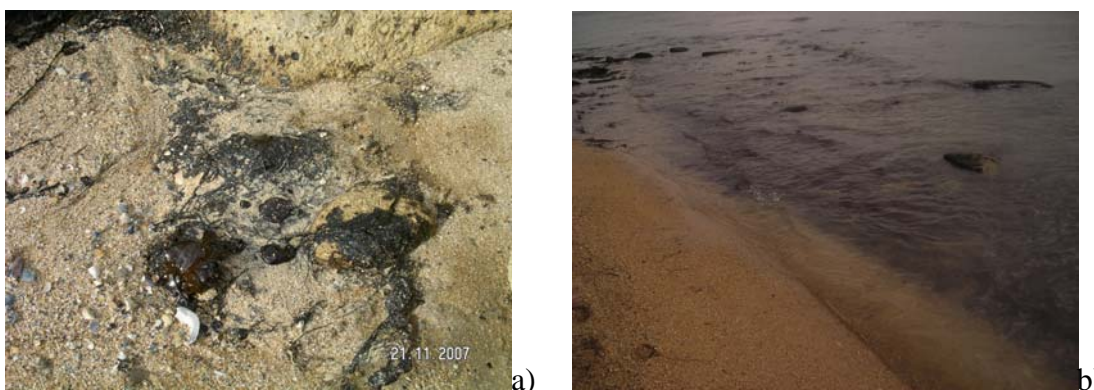
The cove is in the process of being cleaned and it is very easy to observe the successive layers of pollutant on a 40cm thickness of sand. It is possible to distinguish three layers composed of waste from algae and shells mixed with approximately 30% hydrocarbon in volume. These three layers seem to correspond to three successive storms. They are from 2 to 3cm thick. The quantity of pollutant to the linear metre varies from 1 to 10 litres.

At the site, a small submerged patch of oil of about 3 m long, 1 m wide and 10 cm deep was observed. It is assumed that the oil had been mixed with sediment and therefore submerged.

Figure 6 – a) traces of different oil pollution; b) oil sheen in the water

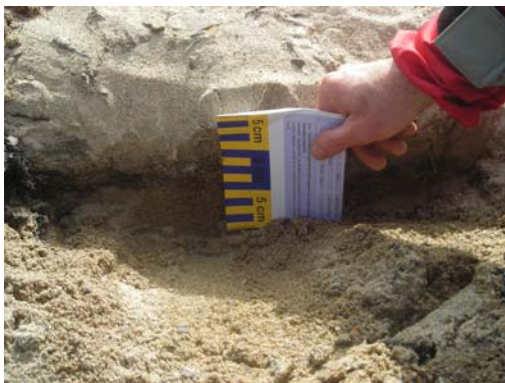
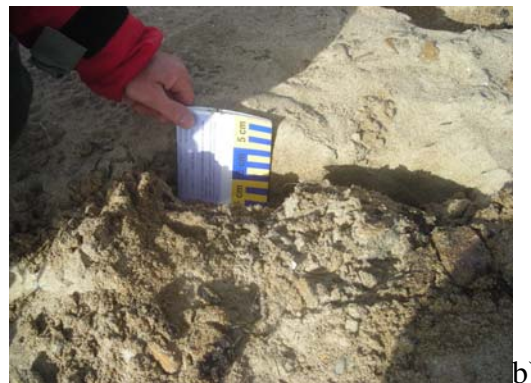
The layer of pollution was 5cm thick and covered in places with a mixture of sand, marine vegetation and shells (Figure 7 a) and b)). The polluted band is 25 m wide along the entire south-western coast of the island.

Figure 7 – a) and b) stratification of pollutant

- In the final stages of the clean-up operations, manual or mechanised sieving should be carried out.
- A structured inspection of the presence of buried layers of pollution would make it possible to identify contaminated and clean areas and the production of a pollution situation map. Small and large specialised machines for sieving and riddling are available. These machines make it possible to treat a band of 1-2 m wide and up to 20cm deep. This special equipment accelerates and facilitates the work by limiting the sand extraction.

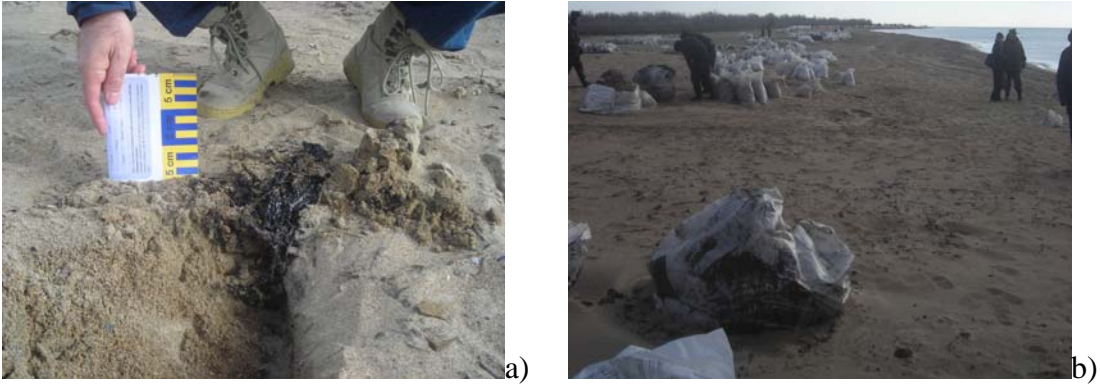
According to the data provided by the Ukrainian Ministry of Emergencies, during the period from 13 November to 22 November 2007 at least 500 people per day and 159 technical units such as tractors and excavators were engaged in beach clean-up operations on Tuzla Island. A total amount of 4000 tonnes of sand and oil mixture was collected and is being transferred to a barge for further transfer to asphalt cement factories located on the Crimean peninsula. A high ratio of sand to oil was observed.

Figure 8 – a) oil/sea-plant mixture; b) collecting activities

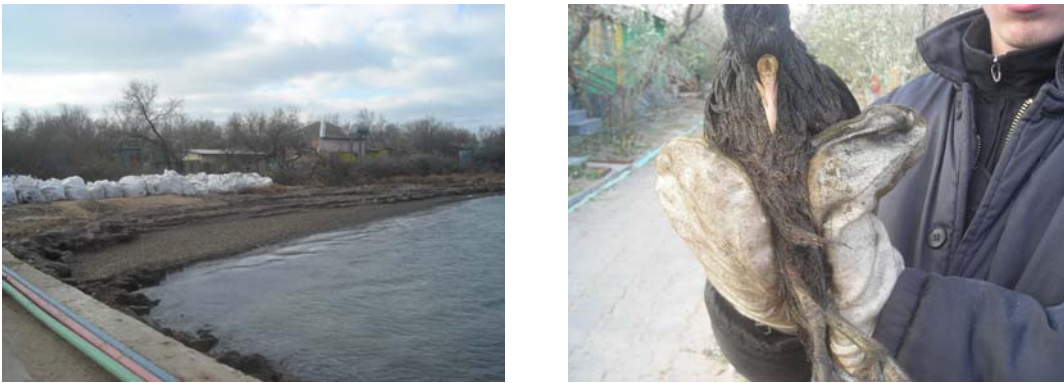
The coast on the other side of the island was not contaminated. Part of the vegetation behind the beach is soiled by waste of contaminated algae carried by the wind. Even though the clean-up operations produced excellent results in term of quantity and speed, there are still significant amounts of pollutant present, especially in the sub-surface. Some oiled seabirds are still being recovered on the island (Figure 9).

Figure 9 – a) temporary collected mixture storage; b) oiled bird

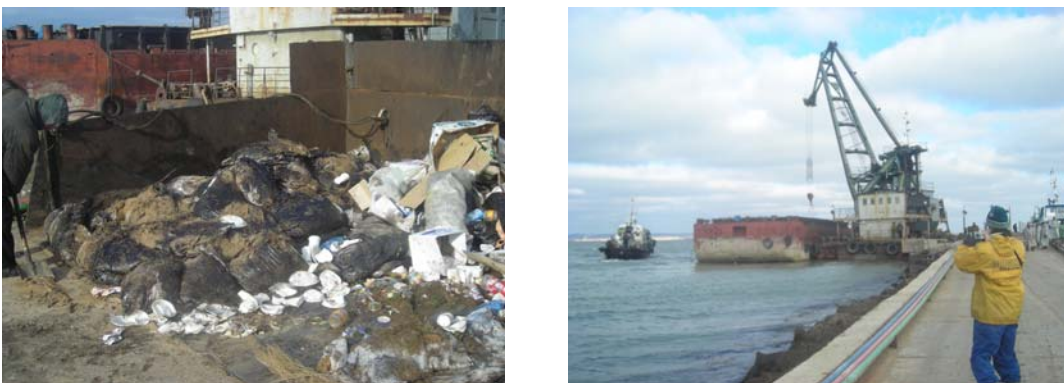
Several tens of tonnes of waste are stored in 50 litre bags waiting to be taken away by a barge with a capacity of 600 tonnes (Figure 10). This barge is moored with a floating crane for the trans-shipment of waste.

Figure 10 – a) and b) temporary storage barge

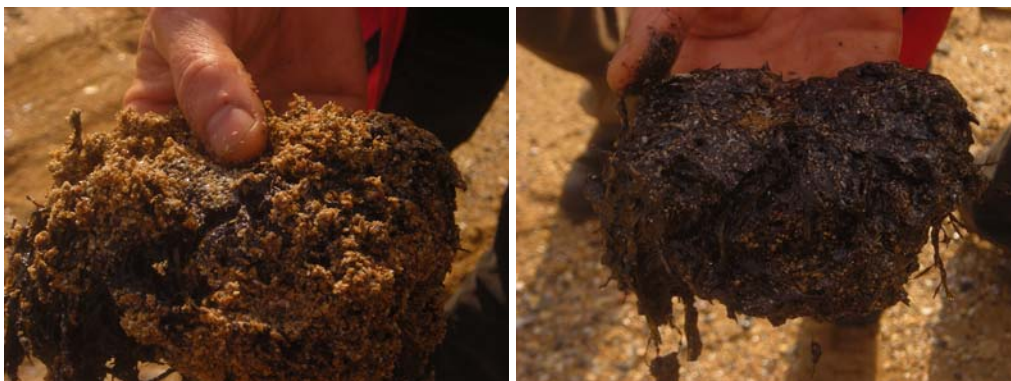
Figure 11 – a) oil/sea-plant/sand mixture; b) oil/sea-plant/sand mixture after washing

- A quick way to optimise the beach cleaning operation in order to avoid extra weight due to the large amount of sediments that could be attached to the oil is to wash the mixture using the seawater on the shoreline on site (preferably with a boom to protect the washing area) (Figure 11 a) and b).

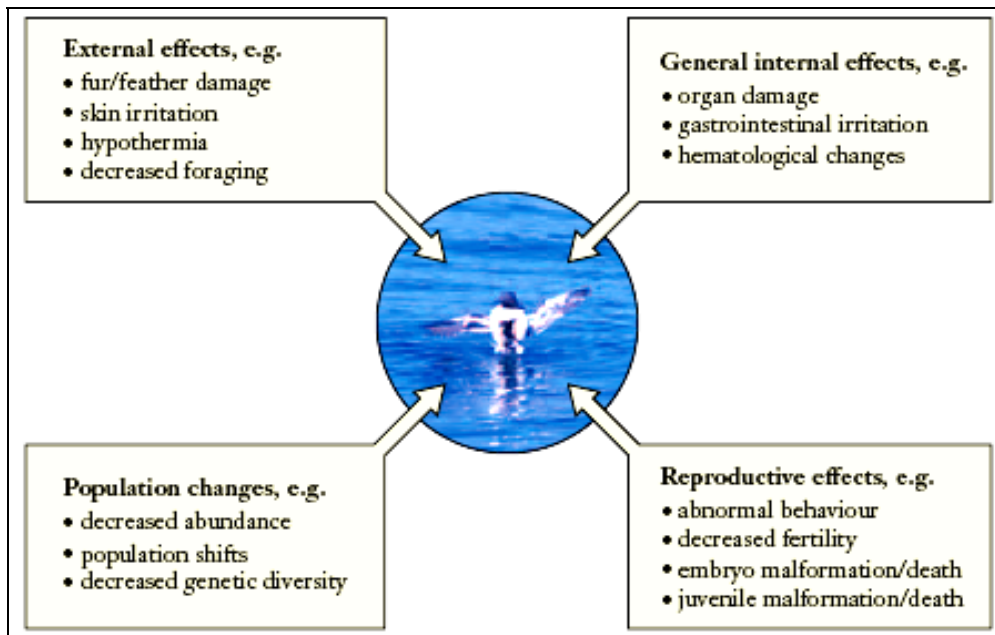
The first, and often most important, effect on birds is external contamination of the feathers from contact with oil (Figure 12). This can cause a disruption of the delicate feather structure which traps warm air next to the body and keeps cold air and water away from the skin. Oil contact temporarily disrupts this intricate structure of barbs and barbules, thus interfering with the bird's ability to thermo-regulate.

Figure 12 – Effects of oil on the birds (IPIECA – 2004)
