TECHNICAL REPORT

Community Civil Protection Mechanism Assessment Mission

Italy Earthquake 2009

April 2009

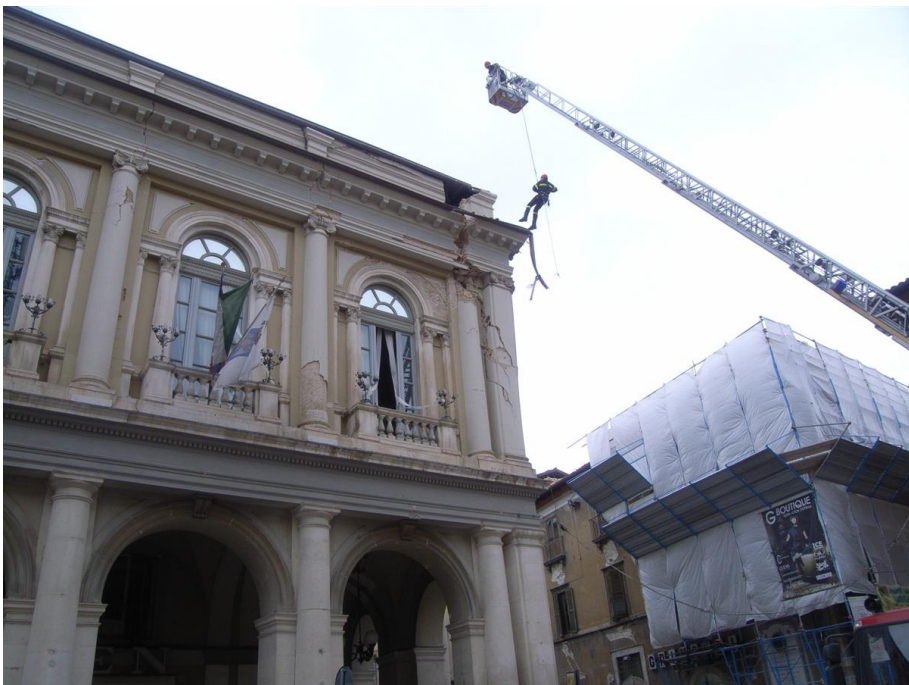
Fire-fighters were not available for such activities during the first phase of the emergency due to their impressive commitments. According to Dr. Clara Modesto, engineer of the Italian fire-fighters, they have been on site with a more or less constant presence of 2300 individuals, and they have been providing 32,000 rescue operations. Besides collaborating in the assessment of normal buildings with 100 experts, fire-fighters are now collaborating in the assessment of the monument buildings and, more importantly, they are putting in place systems for sheltering, by means of their specialized units in timber construction and their SAF units, specialized in operating with helicopters and high cranes, Figure 2.

Figure 2: SAF nucleus of Italian fire-fighters in action

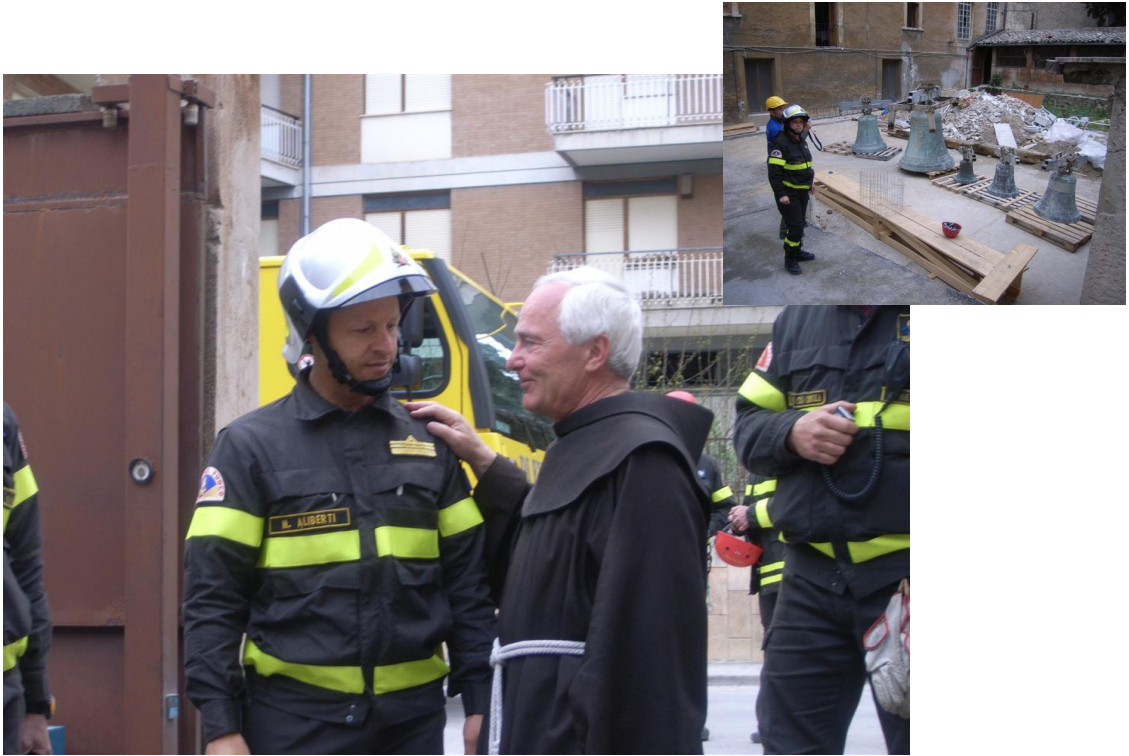
Figure 5: Successful recovery of the bells from the campanile
