Seminar on

SAFE TAILINGS DAM CONSTRUCTIONS

Gällivare, 20-21 September 2001

Technical Papers

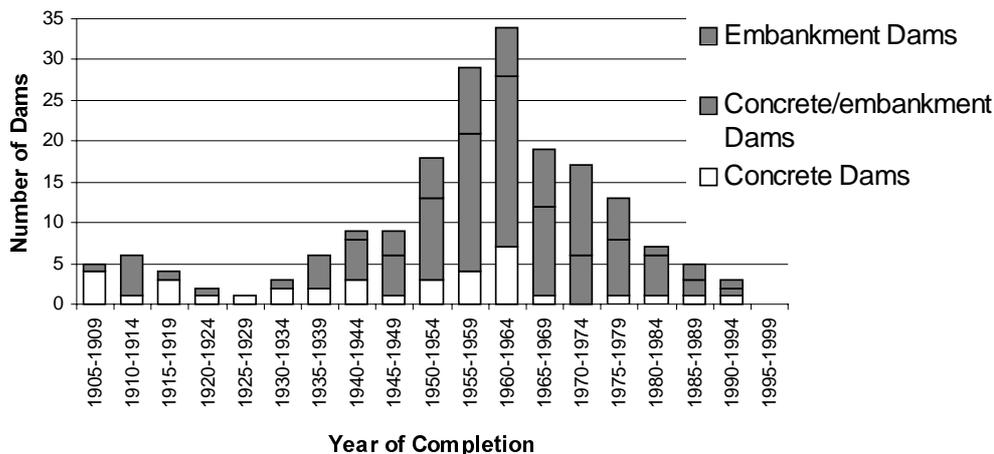
Figure 1. Large hydropower dams in Sweden arranged by year of completion. Source: ICOLD's World Register of Dams, 1998.

There are approximately 10.000 dams in Sweden. About 190 hydropower dams and 15 tailings dams are high dams according to ICOLD's definition. I.e. the height from the foundation level to the crest is 15 meters or more. The estimated numbers of hydropower dams that are high consequence dams according to RIDAS² are about 100.

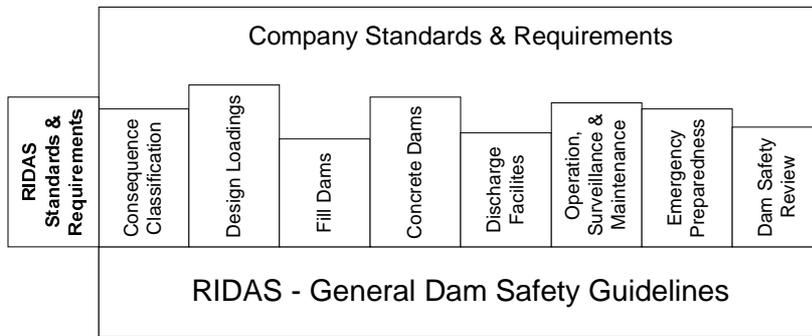
Figure 2. Structure of RIDAS, the Swedish Dam Safety Guidelines

As mentioned earlier in this paper, the Swedish Power Association provided general guidelines on dam safety, RIDAS, in 1997. The mining companies in collaboration have decided and declared that they will follow the guidelines as well when applicable. The mining companies of Sweden are planning a special appendix to RIDAS concerning tailings dams. The main document of RIDAS contains the general dam safety guidelines. Coupled to this are various standards and requirements, see *Figure 1* below.

On top of RIDAS, which defines the minimum requirements, the individual dam owner may apply its own requirements. Legislation does consequently not enforce the guidelines. Under the Environmental Code each dam owner is responsible for doing what is needed to ensure dam safety.

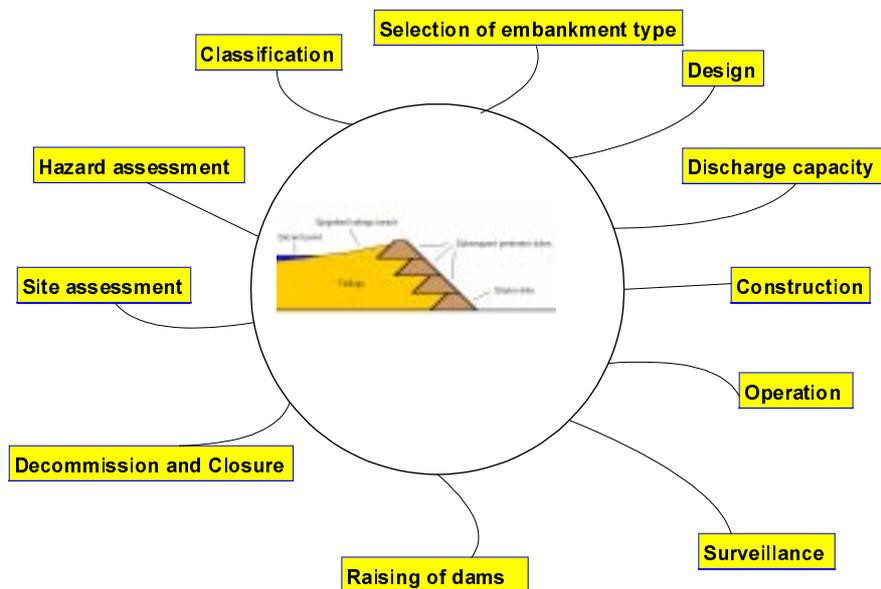
Figure 1 Dam safety management of tailings facility

Dam safety management of tailings dams comprises many parts as shown in **Figure 1**.

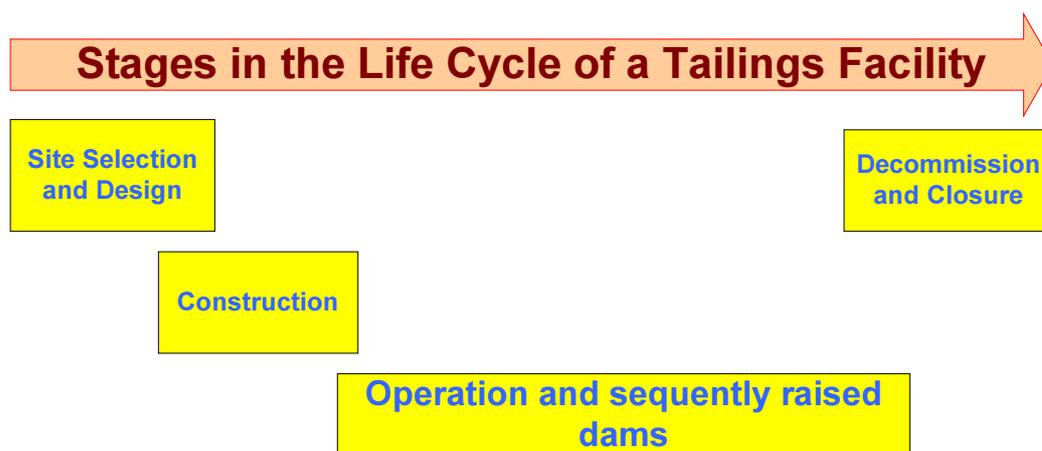
Figure 2 Stages in the life cycle of a tailings dam

The main difference between a conventional dam and a tailings facility is the tailing dam operation phases as shown in **Figure 2**. Each phase has different dam safety requirements. In some tailings facilities surveillance in some kind will be needed hundreds of years after closure.

For conventional dams three faces can be identified (construction, operation and abandonment). These phases can not fully be compared to any of the phases in terms of design and other safety evaluation requirements.

Another difference is that for tailings dams there is a necessity for the design engineer's input all throughout the production phase. In the case of conventional dams, the design engineer's input ends shortly after the first filling when the dam is handed over to the operator.

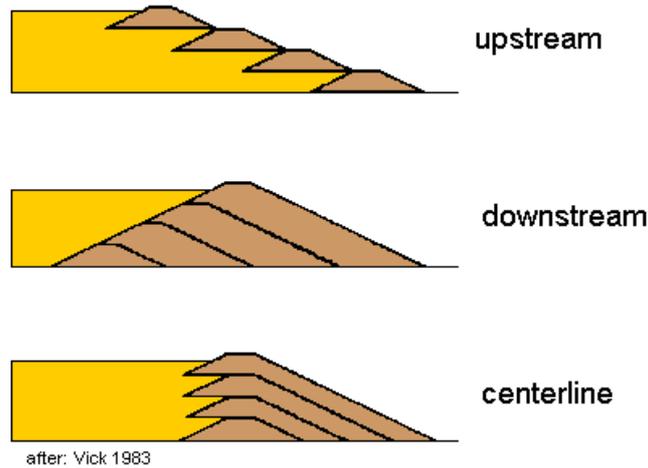
Types of sequentially raised tailings dams

Figure 3
Types of sequentially raised tailing dams

Various classifications of tailings dams may be used for different purposes. The most known is the classification based on the methods of construction, upstream, downstream and centreline tailings dams, see *Figure 3*.

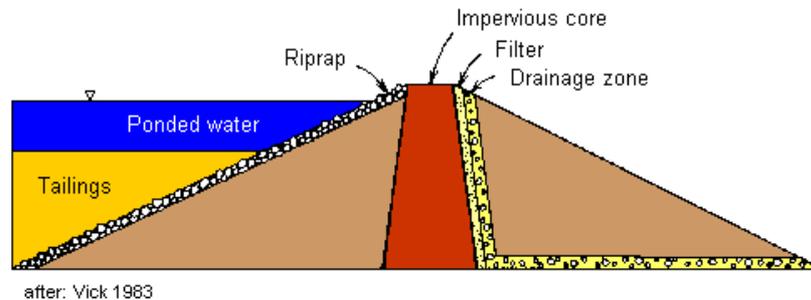
Water-retention type dam for tailings storage

Figure 4 Tailings dam constructed as a traditional zoned embankment dam

Tailings dams are sometimes also constructed as traditional embankment dams, see *Figure 4*.

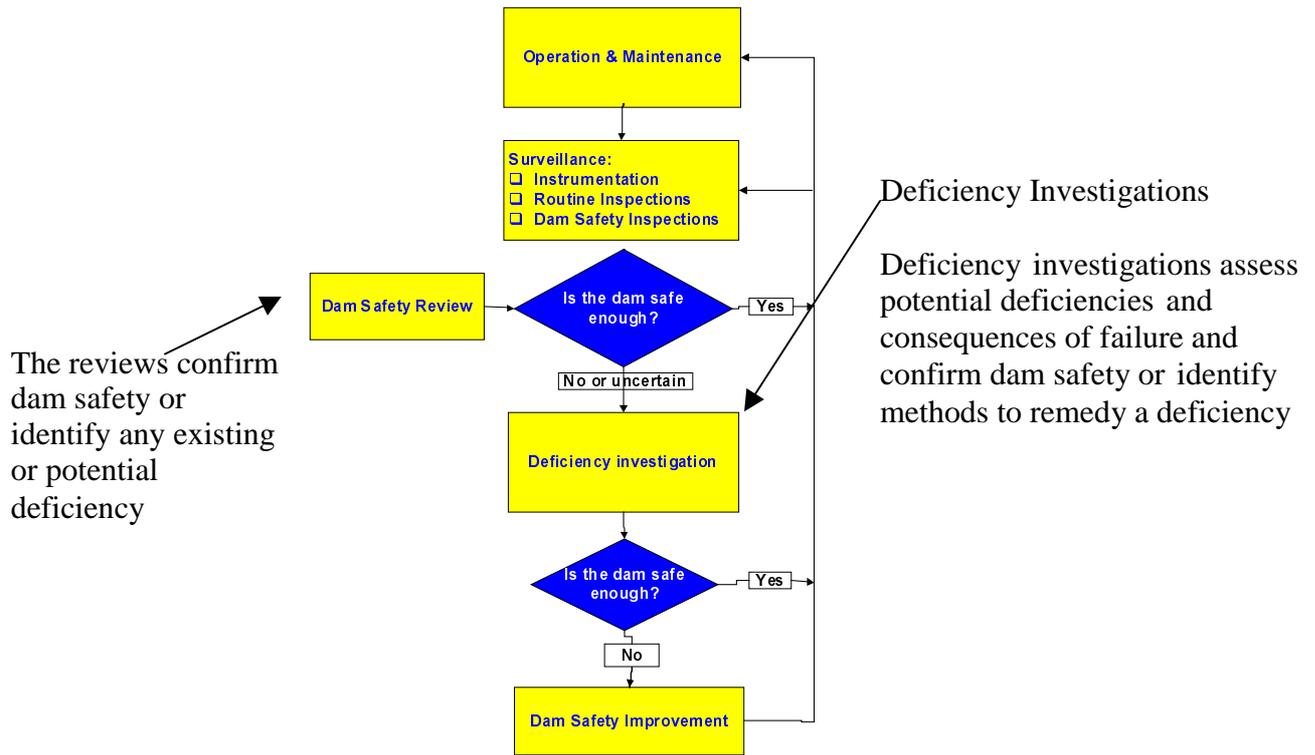
Figure 5 Different types of surveillance incorporated in a “Dam Safety Programme”

The results of the different inspection types needs to be incorporated in a “Dam Safety Programme” illustrated in the following flow chart:

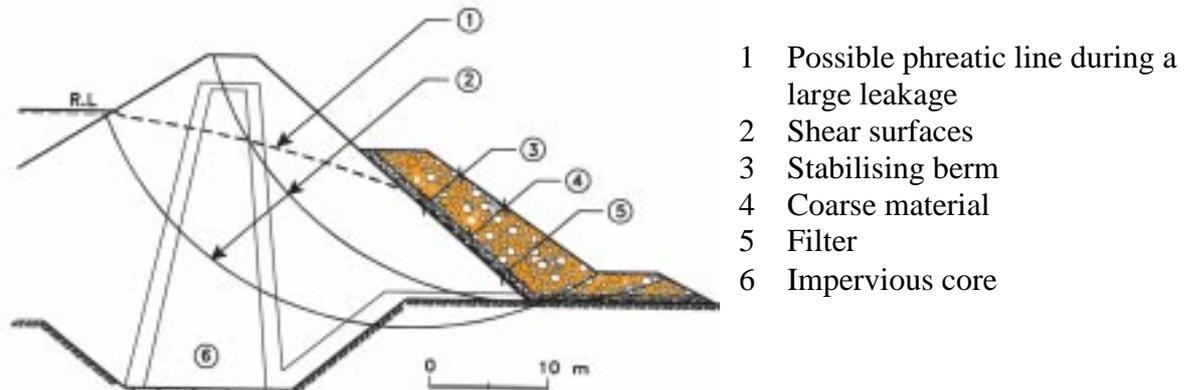
Figure 6 Strengthening of the downstream toe to withstand large leakage

For embankment dams many possible failure modes e.g. initiated by internal erosion results in seepage followed by slope unravelling or scouring at the downstream toe. The risk for a progressing failure is usually assessed assuming that the governing factors are discharge flow, toe-stone size and slope angle.

This requirement will result in that many of the Swedish embankment dams will be strengthened by toe berms in principle as shown in **Figure 6**.

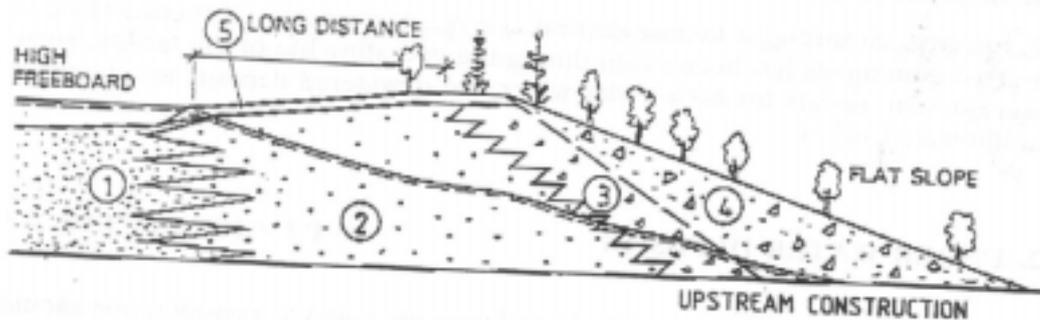
- 1 Fine tailings (from operation face)
- 2 Coarse tailings (from operation face)
- 3 Support fill (from operation face)
- 4 Support fill, long-term stable (modification on closure)
- 5 Impervious cover and erosion protection (modification on closure)

Figure 7 Closure of dams for under water deposits

Decommission and closure have been comprehensively presented in the ICOLD Bulletin 103, (1996). The design for dams for under water deposits are shown in **Figure 7**. It should here be noted that the phreatic surface must be controlled by adequate drainage.

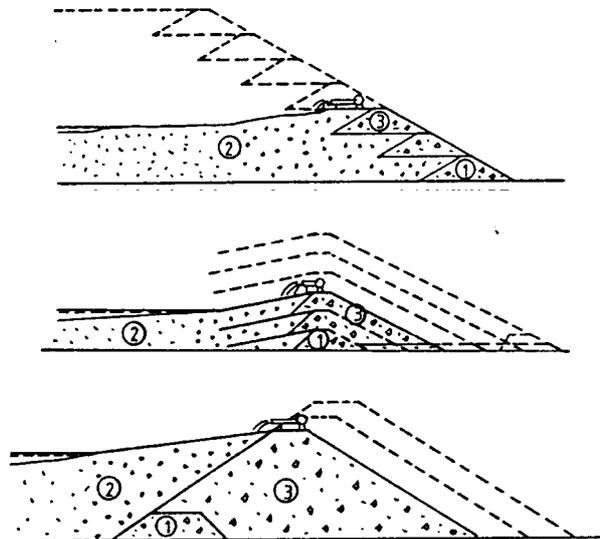
Figur 1 Upstream, Centreline and Downstream construction using tailings as construction material.

(① Starter wall, ② deposited tailings, ③ support fill)

There are almost as many different tailings dam construction methods, as there are tailings dams, but generally they can be divided into three different methods; upstream, centreline and downstream, see figure 1.

-Using the downstream technique the crest of the dam wall moves progressively downstream as the impoundment is raised. For each raise the volume of material needed will increase exponentially, which will result in relatively high construction costs. The footprint area will successively increase as well. The downstream dam is not as sensitive as the upstream dam as the dam is built on "hard ground" instead of deposited tailings.

-With the centreline method the crest remains in a constant position in plan. The method is basically a combination of the upstream and downstream method and all qualities are in-between the qualities of the two other methods.
