# HAITI Earthquake January 2010 Damage Assessment Map

Date: 19 January 2010  
Global Atlas ID: 1882  
Version: 2  
Producer: Joint Research Centre

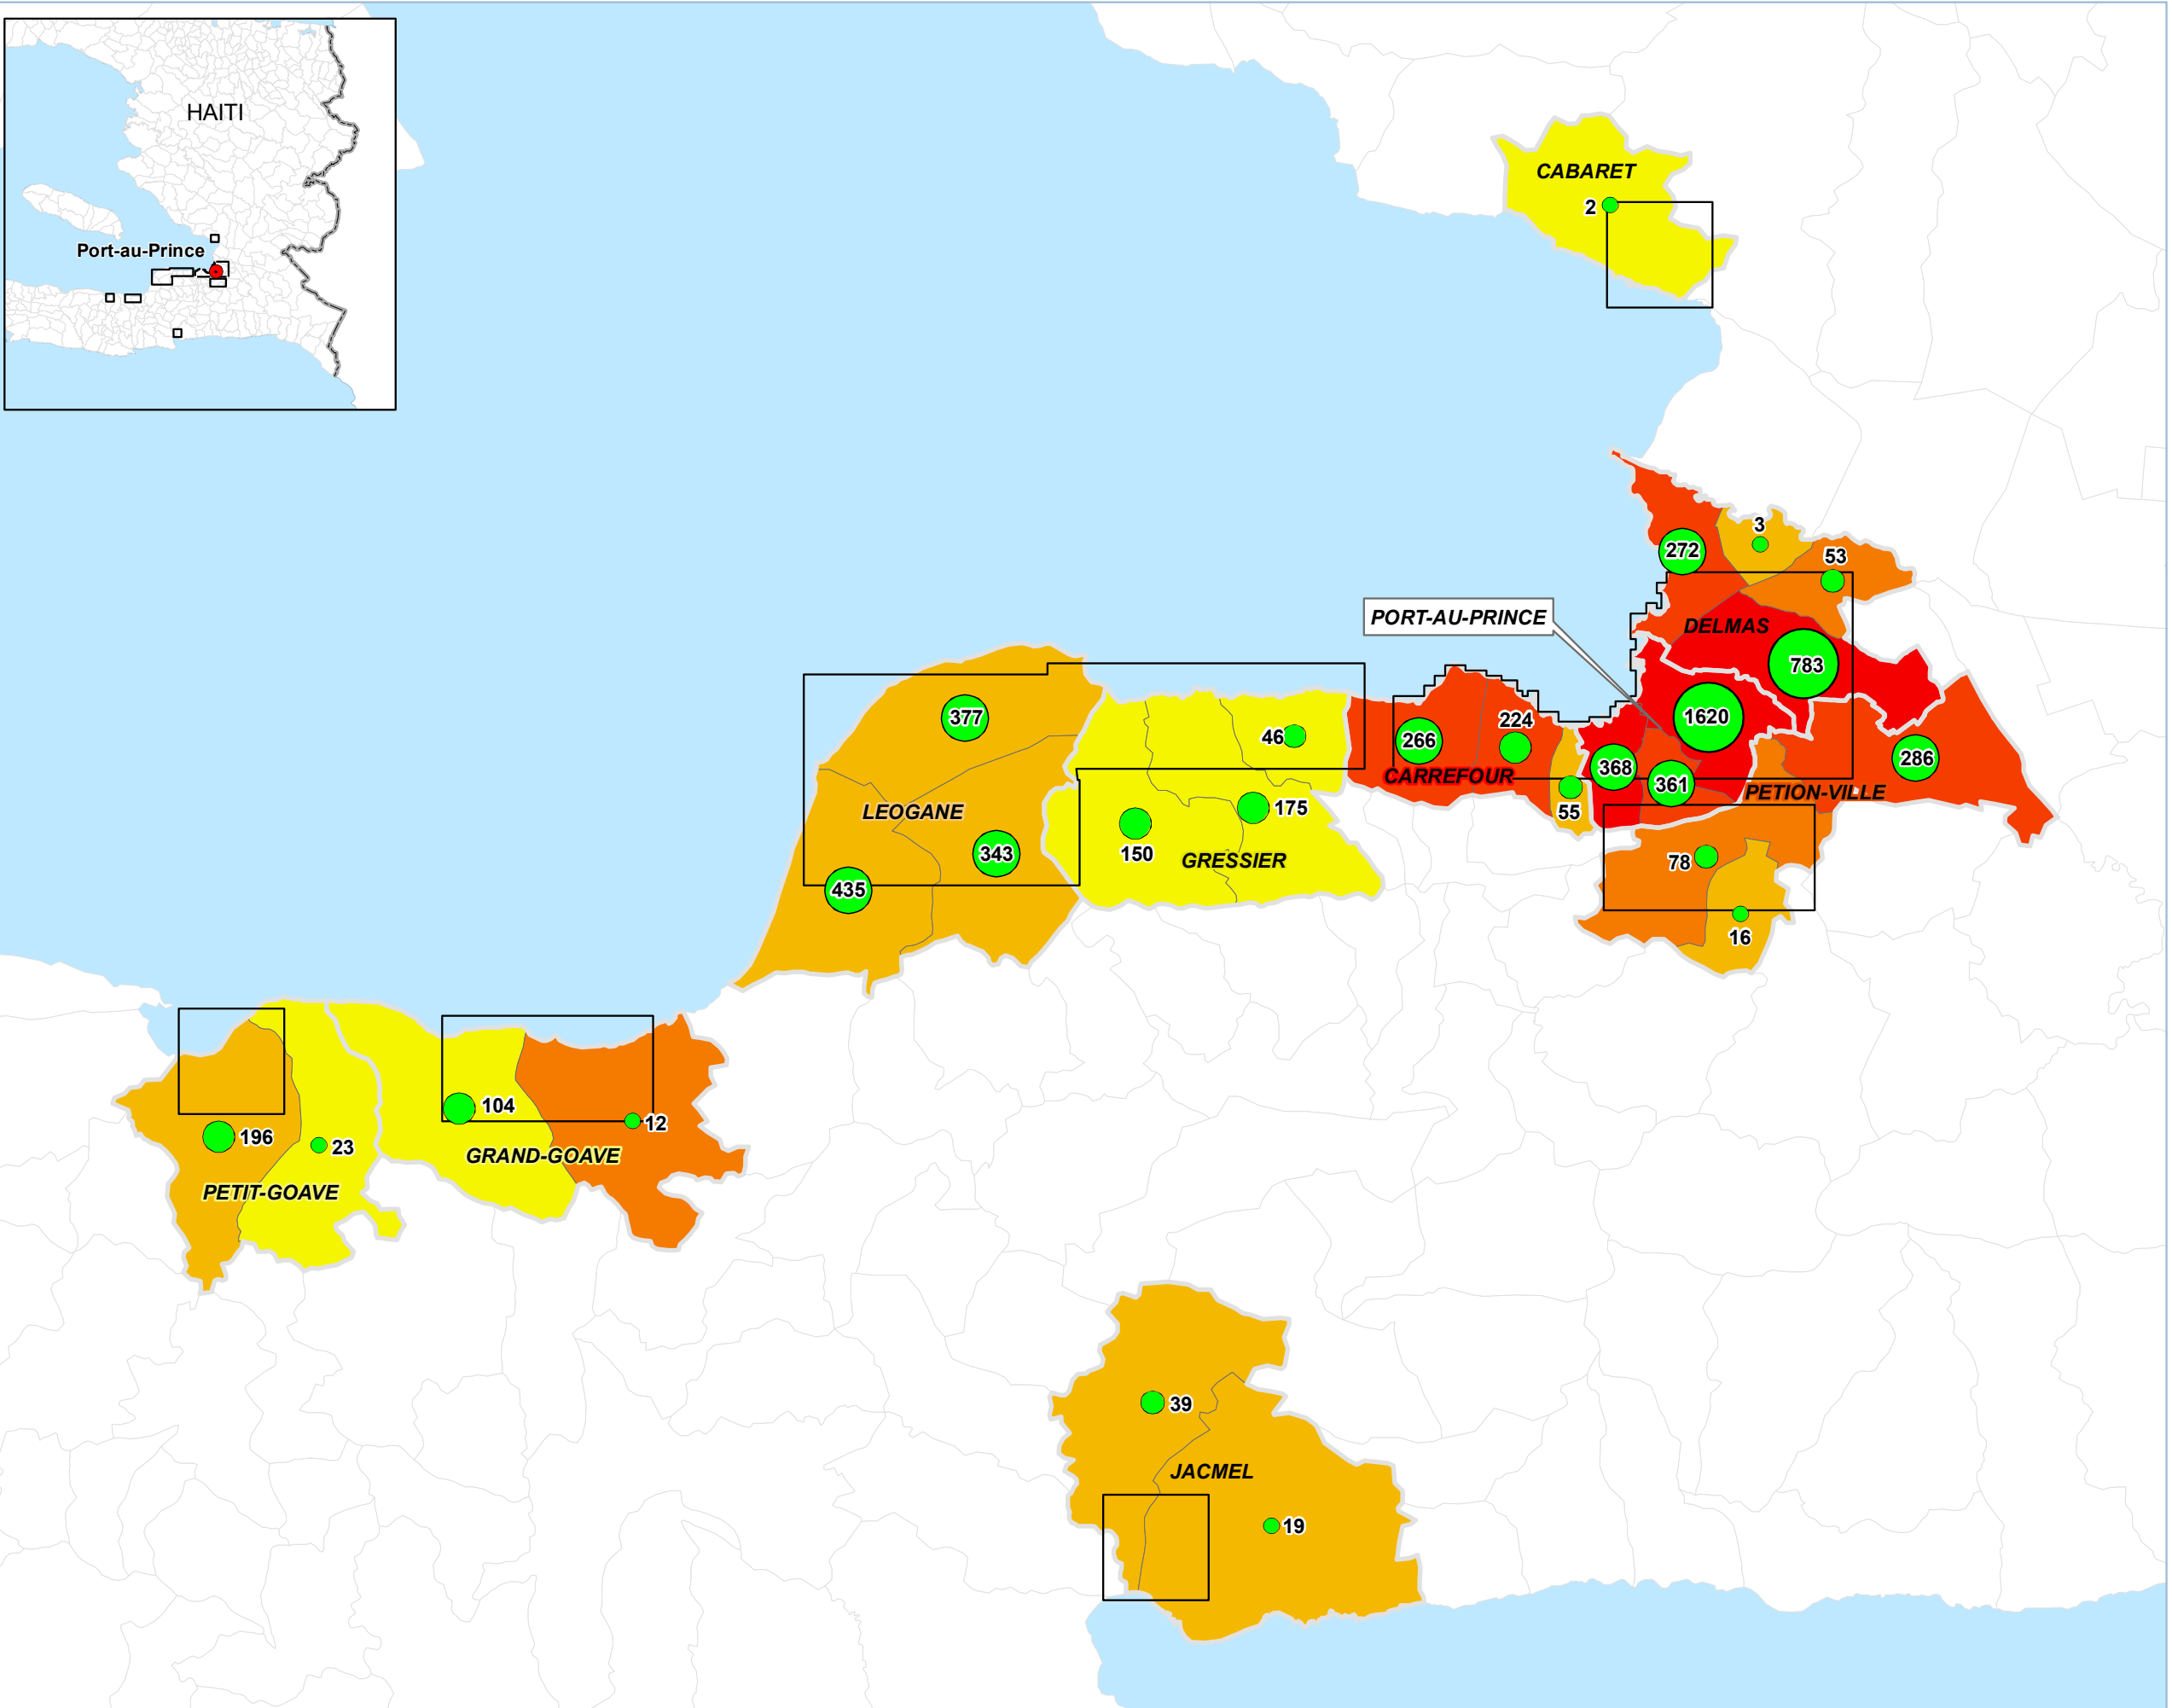
The JRC has carried out a rapid preliminary damage assessment in South Western Haiti. The JRC has interpreted post-disaster GeoEye and WorldView2 satellite imagery. As pre-crisis reference several QUICKBIRD satellite data sets available in Google Earth were used. The JRC counted damages and flagged those that are either damaged or destroyed. The counting and classification of damages was done as manual labelling following visual interpretation of the pre- and post-event images. This map shows the population, the damages and destructions summarized per Commune/Section. Note that damages refer only to the area of analysis and not the entire Communes.
